EVALUATION OF AIRFIELD BEACON AND PAPI UNITS

WINTER HAVEN REGIONAL AIRPORT

FINAL REPORT

May 2022

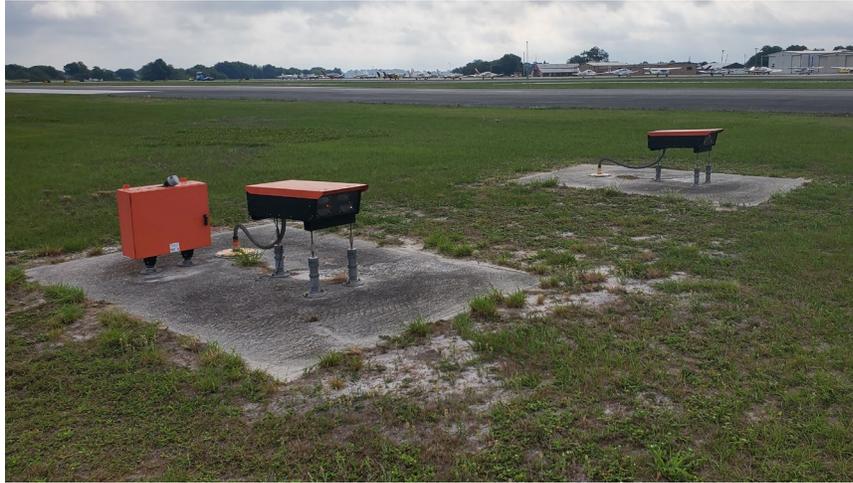
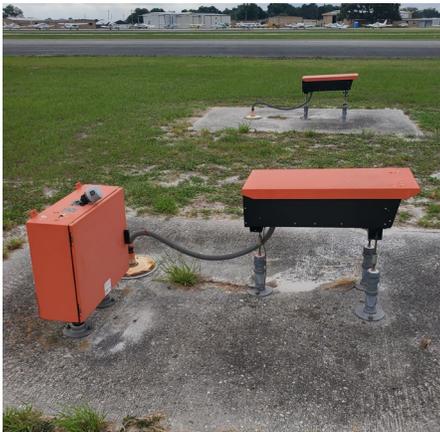
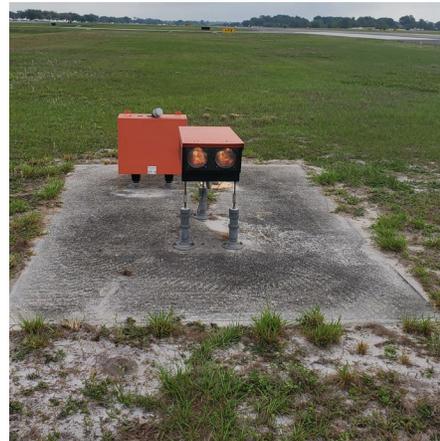
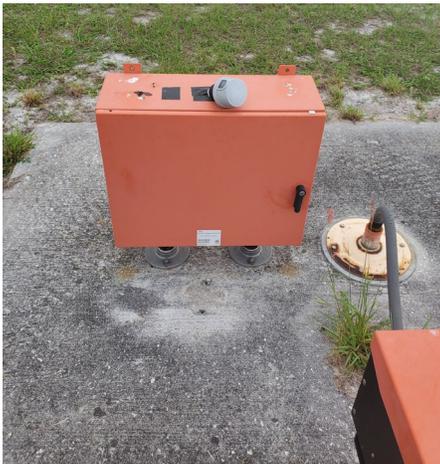
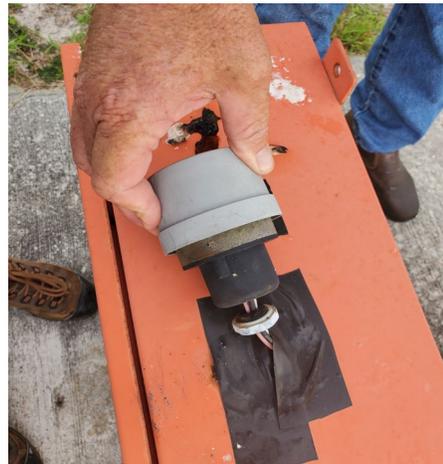
Runway 5, Existing L-881 2 Box PAPI System

Runway 5 is equipped with an ADB Airfield Solutions PAPI system manufactured and installed in 2012, **(See Appendix B, Figures 1-5)**. The PAPI system for this runway end is 10 years old. Runway 5 PAPI does not have a power disconnect at the PCU. Power needs to be locked out and tagged out at the ALV when working on this unit. The photosensor, located on the top of the PCU, controlling the intensity of the lighting is damaged and will eventually allow water to enter the PCU, **(See Appendix B, Figures 4&5)**. An immediate repair of the photocell and closure of the opening should be undertaken to prevent damage to the internal electronics of the PCU.

LED PAPI units are available providing substantially greater lamp life, estimated at 50,000 hours, than the current incandescent bulbs as well as reducing the electrical load at each location. The load for each existing incandescent PAPI system is approximately 1650 VA whereas the equivalent LED system would require 264 VA for each installation. Representing an 84% reduction in electrical load per system. The circuit breakers in the vault would be replaced as well as the conductors from the vault to the PAPI locations. Type B, CCR driven units, would be preferred depending on vault space for a new CCR.

NAVAIDs (PAPIs,) – AVCON recommends the replacement for each of the Airport-owned non-federal PAPIs. The PAPI for Runway 23 is beyond its useful life and the PAPI for Runway 5 is approaching its end of useful life. AVCON would recommend installing LED PAPI units, (**See Appendix B, Figure 17**), which will offer lower operating costs and maintenance of the lighting system. In addition to design the following items will be required:

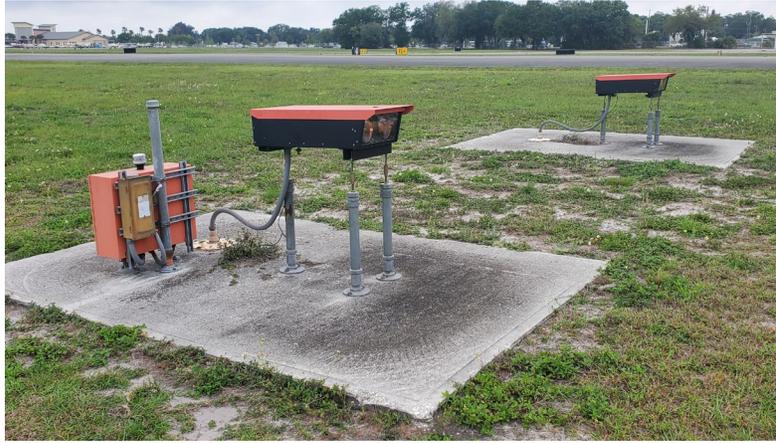
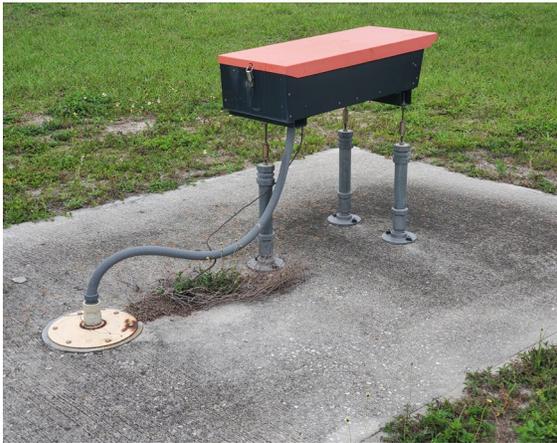
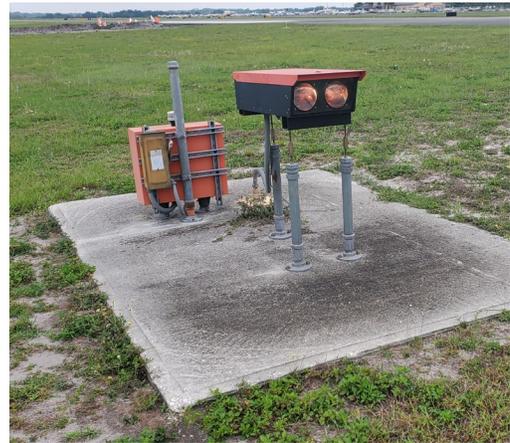
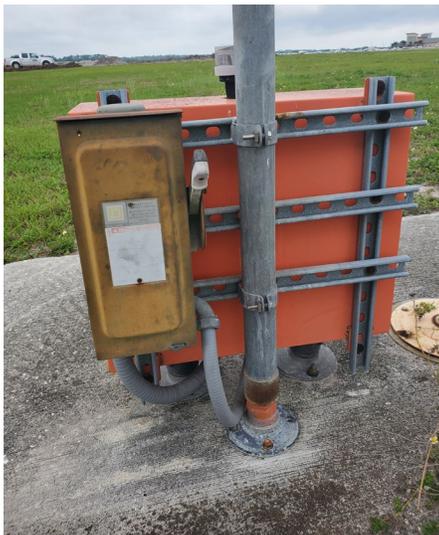
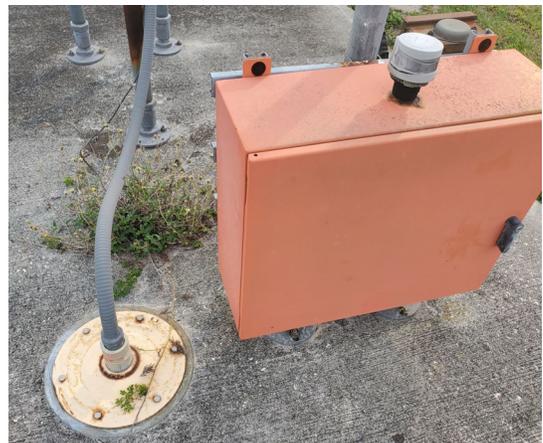
Runway 23, Existing L-881 2 Box PAPI System

Runway 23 is equipped with a ADB Siemens PAPI system manufactured and installed in 2000, **(See Appendix B, Figures 6-10)**. The PAPI for this runway end are 22 years old. Runway 23 PAPI has a power disconnect at the PAPI location and does not meet FAA criteria requirements as stated in Engineering Brief 79, **(See Appendix B, Figures 8&9)**. EB 79 does not permit the disconnect attached to the PCU to be within the ROFA of the runway. This disconnect must be placed outside the ROFA.

The existing external disconnect switch and the PCU are mounted on frangible mounts, but the component location does not comply with FAA EB 79 fixed-by-function criteria.

FAA AC 150/5345-28G, Precision Approach Path Indicator (PAPI) Systems, 9/29/2011 states that the maximum allowable distance between the outside light housing assembly and the PCU is 100 feet. At GIF the distance from the outside PAPI light housing assembly to the ROFA is approximately 140 feet. The 100-foot requirement limits the ability to move the PCU out of the ROFA. For this reason, current driven FAA Style B PAPIs should be considered. Another reason to consider using a current driven PAPI is the routing of power cables to the PAPI units in the field. The existing voltage-powered circuits are in the same duct bank and manhole system as the 5 kV airfield lighting series circuit cables. Chapter 5 of National Electric Code (NEC) Section 300.3(C) prohibits mixing the 5 kV airfield lighting series circuit unshielded cables with the 1000 volt and less voltage powered PAPI cables in the same raceway or enclosure.

If Type A, voltage driven units, are determined to be the installed a small 30 AMP NEMA 4X disconnect would be installed outside the ROFA to permit disconnecting the power from the PAPI in the field to service the PAPI unit and an alternate conductor pathway would be determined to separate the voltage driven circuit from the 5kv airfield circuits.

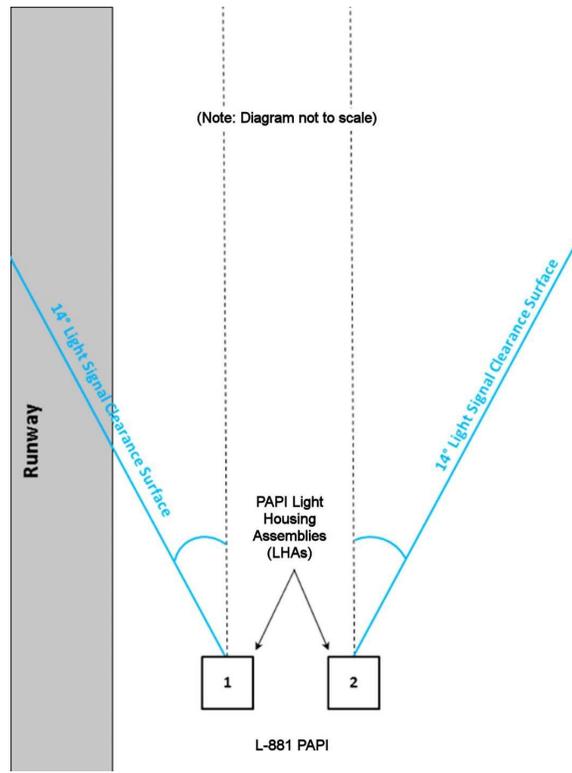
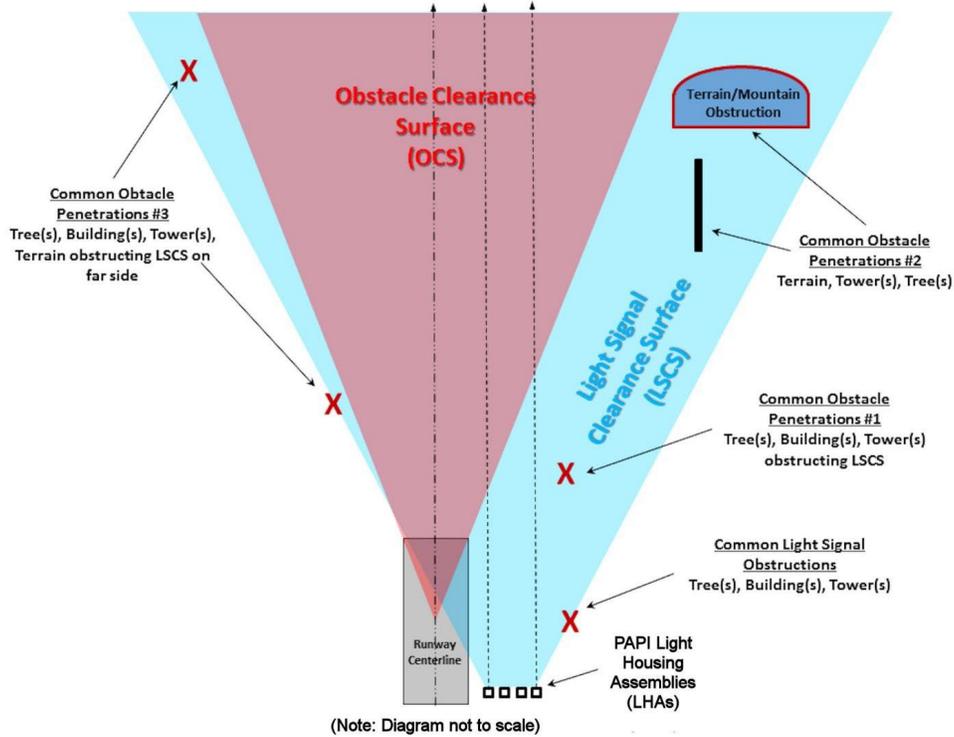
EB 95, Light Signal Clearance Surface (LSCS) Criteria

EB 95 extends the evaluation of the obstacle clearance within the lateral limits of the visible light beam, even if it means going **outside** the standard 10-degree to 10-degree obstacle protection area centered on the runway. It also states, if the obstacle outside the standard 10-degree azimuth poses a risk to aircraft maneuvering to land, the azimuth spread of the light beam shall be suitably restricted so that the object remains outside the confines of the light beam. In basic terms, the FAA is concerned with obstacles that will interfere with the PAPI light beam outside of the 10 degree zone and has defined a new Clearance Surface and Survey requirement referred to as: PAPI Light Signal Clearance Surface (LSCS). This is in addition to the previous OCS, **(See Appendix B, Figures 11&12)**

The LSCS originates at the LHAs and proceeds outward at an angle of 1 degree less than the lowest course signal and extends 14 degrees to the left side of the first LHA (closest to runway), the area between, and 14 degrees to the right side of the outermost LHA (farthest from the runway), **(See Appendix B, Figure 11)**. The lowest course signal for 4-box PAPI (L-880) is the aiming angle of the third LHA and for 2-box PAPI (L-881) is the aiming angle of the unit farthest from the runway. The LSCS extends from the point of origin, as shown in **Figure 11** for a two box L-881 PAPI, and to a distance of 8 nautical miles from the runway threshold.

This survey shall be completed to determine obstacles within the LSCS and mitigation efforts shall be undertaken to limit obstacles with the visible light beam of the PAPI. If the obstacle cannot be removed, the most common method of mitigation is to baffle the PAPI light beam, **(See Appendix B, Figure 12)**.

- a) A topographical survey to include the runways thresholds and runway centerline for the first 1200 feet from each runway end will be required to verify/site the location of the new PAPI units.
- b) In accordance with EB 95, a Light Signal Clearance Surface (LSCS) survey will be required to establish the obstacle clearances within the Light Signal area within the approach and determine requirements to remove the obstacles and/or baffling of the PAPI unit to comply with FAA EB 95.
- c) An FAA Flight Check of the new PAPI systems will be required to commission the units for use.

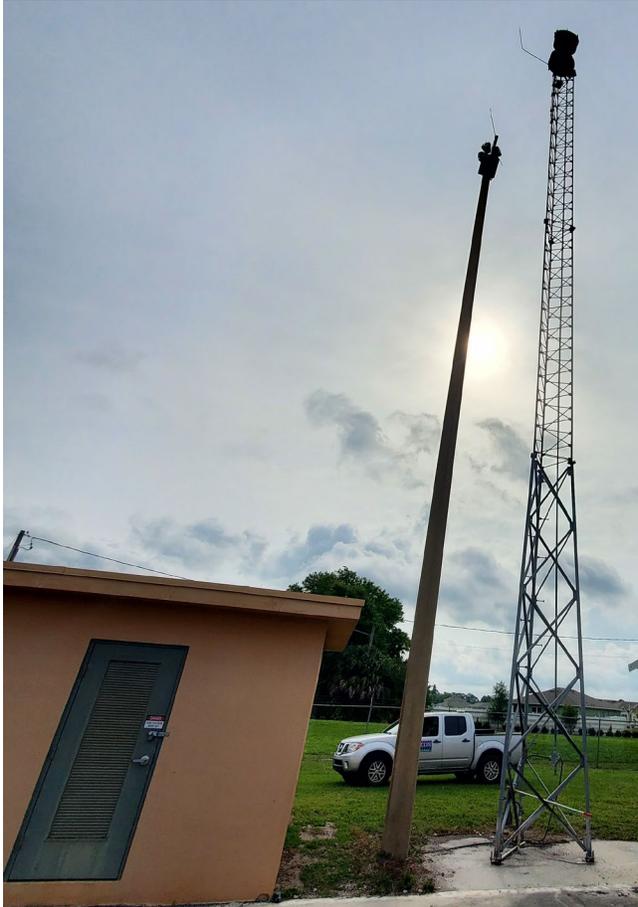
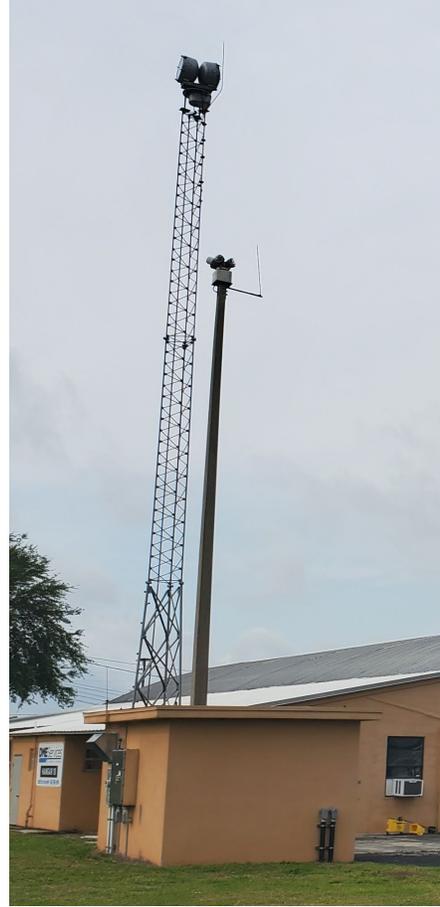
Existing Beacon

Panel A provides power to beacon that is immediately next to the Airfield Lighting Vault, **(See Appendix B, Figures 13-16)**. The source of power for the Airport Beacon is in the Airfield Lighting Vault (ALV) from an appropriately sized circuit breaker located in Panel A and a contactor that is interfaced to the airfield lighting control system. The line voltage for the beacon is 240 Volts, 60 Hz, single phase power.

Each beacon pole, **(See Appendix B, Figures 13&14)**, does have a strike termination device, air terminal, installed, but no visible grounding electrode can be identified for the concrete pole mounted RB-4 unit. The Steel tower for the DCB-224 Beacon is bonded at the base to a grounding electrode with the steel tower providing the connection between the beacon mount and the grounding electrode. A separate bonding conductor is not present between the air terminal and grounding electrode.

LED Beacon units are available providing substantially greater lamp life, estimated at 50,000 hours, than the current incandescent bulbs as well as reducing the electrical load by approximately 75% over traditional metal halide lamps. The circuit breaker in the vault would be replaced as well as the conductors from the vault to the beacon location. A small 30 AMP NEMA 4X disconnect would be installed next to the beacon to permit disconnecting the power locally from the beacon. A siting study will be conducted to determine the best location of the beacon assembly and determine if a tipdown pole assembly may be used in lieu of the traditional steel structural pole assembly. A Tell-Tale relay will be installed to the beacon along with proper obstruction lighting. The Tell-Tale relay initiates the illumination of the obstruction light if the beacon lighting should fail. All new grounding and bonding of the beacon and beacon pole will be included in the replacement design.

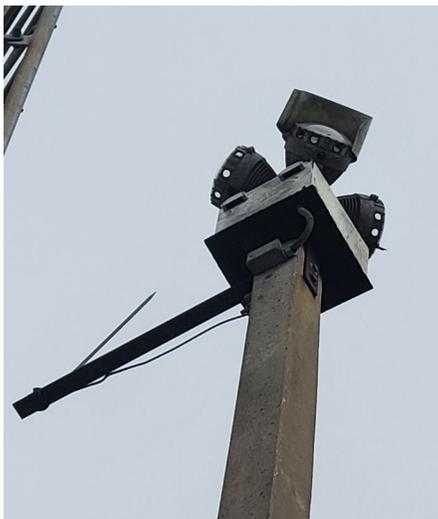
Figure 15

GIF has two beacon assemblies located next to the Airfield Lighting Vault. The first beacon is mounted on a concrete pole and is an RB4, 4 headed beacon assembly which was manufactured by ADB in the late 1980's. This unit has been discontinued prior to 2000 and is no longer supported by the manufacturer. The unit is estimated to be at least 22 years old and is not functioning, **(See Appendix B, Figure 15)**.

Airport Rotating Beacon – AVCON recommends the Airport's rotating beacon and tower be replaced as described within this report. LED Beacons are available which will reduce the operating costs of GIF and lower the maintenance of the beacon, (**See Appendix B, Figure 18**). AVCON also recommends the existing steel frame beacon tower be removed and install the new beacon on a tipdown pole assembly, (**See**

The Airport Beacon is more than 20 years of age. Replacement components, and service are increasingly difficult to obtain and maintain a serviceable Airport Beacon. The beacon is beyond the useful life defined in FAA Order 5100.38D Change 1, dated February 26,2019, Table 3-7 "Minimum Useful Life".

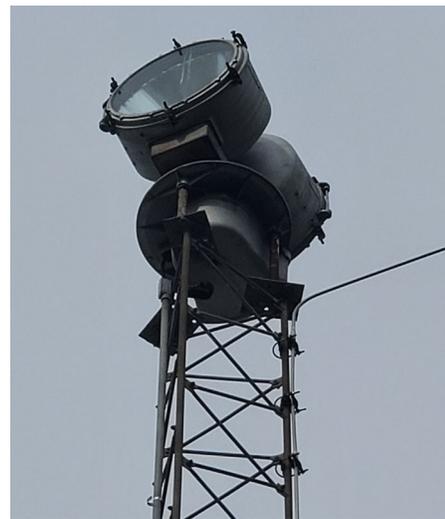
Figure 16

The second unit is a DCB-224 Beacon assembly which was manufactured by Carlisle and Finch Company and was originally designed for use in lighthouses throughout the United States in the 1950's. The unit uses two 400-watt metal halide lamps enclosed in an aluminum drum assembly with a set of parabolic reflectors for the light output. This unit is no longer in production and service components can be difficult to obtain. This beacon assembly is mounted atop a steel cage type mast estimated to be 60 feet in height. The mast does not have a climbing system to secure a maintenance person and requires of a motorized lift to perform bulb changes or maintenance of the unit, **(See Appendix B, Figure 16)**.

Airport rotating beacons typically have an expected life of up to 20 years depending upon the impacts of environmental conditions, as well as the quality and frequency of the maintenance performed over the life of the equipment. The Airport's existing DCB-2224 L-802A high intensity rotating beacon is estimated to be more than 30 years old, has been impacted by the environmental conditions, and is obsolete, beyond its useful life due to unavailability of spare parts. The RB-4 beacon assembly is estimated to be more than 22 years old, is no longer in production and beyond its useful life due to unavailability of spare parts. It is ultimately recommended to produce a project for a complete airport rotating beacon and pole assembly replacement.
