**WINTER HAVEN'S GILBERT AIRPORT (KGIF)  
WILDLIFE HAZARD SITE VISIT  
WINTER HAVEN, POLK COUNTY, FLORIDA**

**NOVEMBER 6, 2018**

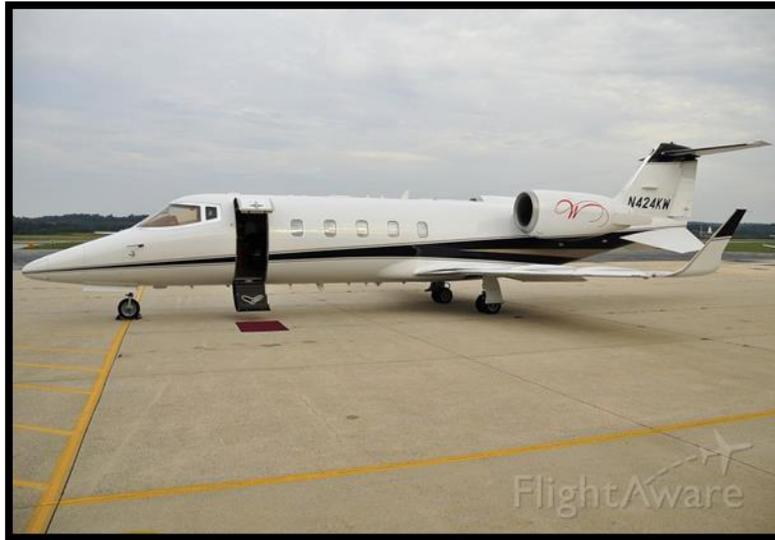
The earliest wildlife strike on the Learjet-60, tail number N424KW, in 2011 had no damage (N) reported by airport operations when the aircraft was on approach to Runway 23 at dusk. The strike was reportedly an unknown bird-small and it may have involved an engine ingestion according to the FAA National Wildlife Strike Database report.

**LEARJET-60, N424KW – STRIKE REPORTED NOVEMBER 29, 2017**

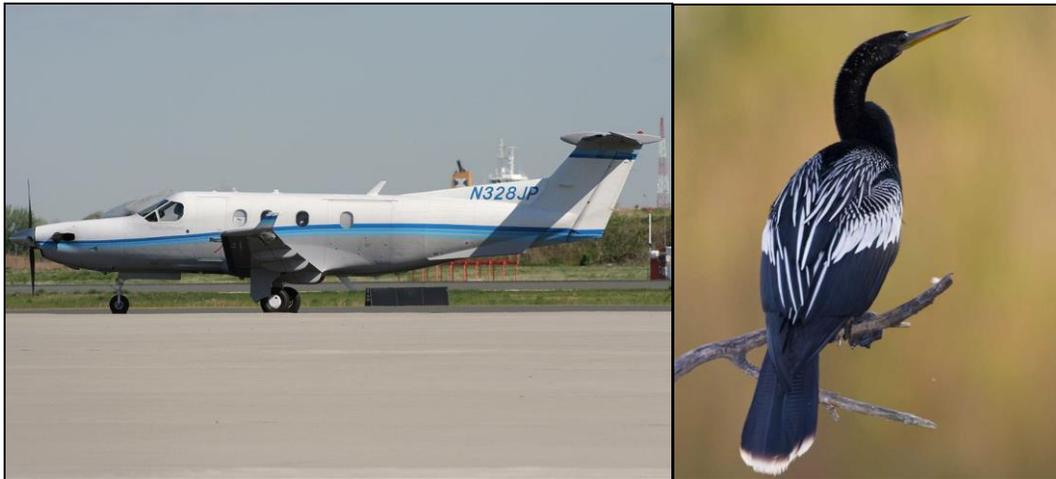
The most significant wildlife strike reported in the past involved an Anhinga (*Anhinga anhinga*) that struck the windshield, nose, propeller, and right wing, doing Substantial (S) damage to the aircraft during climb at 6,000 ft. from Runway 5. The Pilatus aircraft, tail number N328JP, wildlife strike was reported to FAA by airport operations. The strike occurred during daytime hours with no clouds reported.

**PILATUS AIRCRAFT N328JP – STRIKE REPORTED SEPTEMBER 1, 2012**

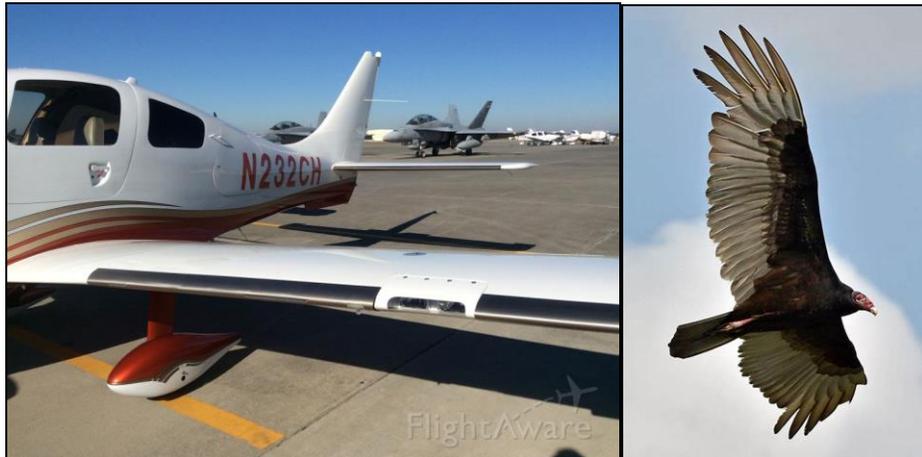
The most recent wildlife strike reported involved a Turkey Vulture (*Cathartes aura*) that was struck by a private aircraft Cessna C-400 Corvalis aircraft that encountered a Turkey Vulture on approach to Runway 5, with some clouds noted during daytime hours. The aircraft sustained Minor (M) damage primarily to the painted finish, with no structural damage reported.

**CESSNA C-400 CORVALIS AIRCRAFT N232CH – STRIKE REPORTED NOVEMBER 23, 2013**

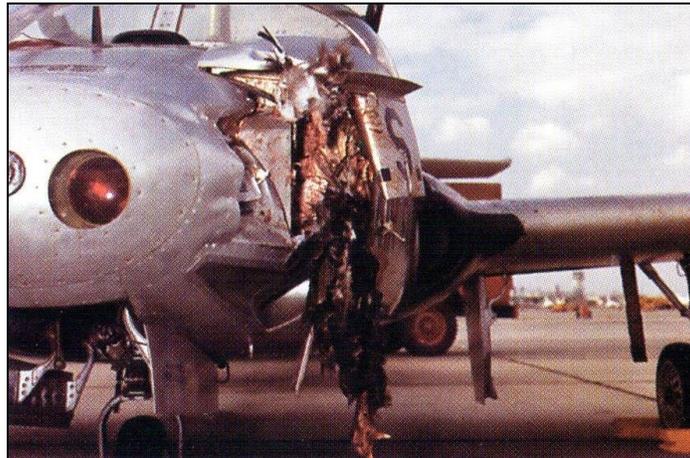
Turkey Vultures are fairly common hovering over airport and highways. Their unpredictable soaring characteristics can frequently result in causing serious impacts to aircraft, and in some cases resulting in Substantial damage to an aircraft.

**MILITARY AIRCRAFT-TURKEY VULTURE SUBSTANTIAL DAMAGE STRIKE**

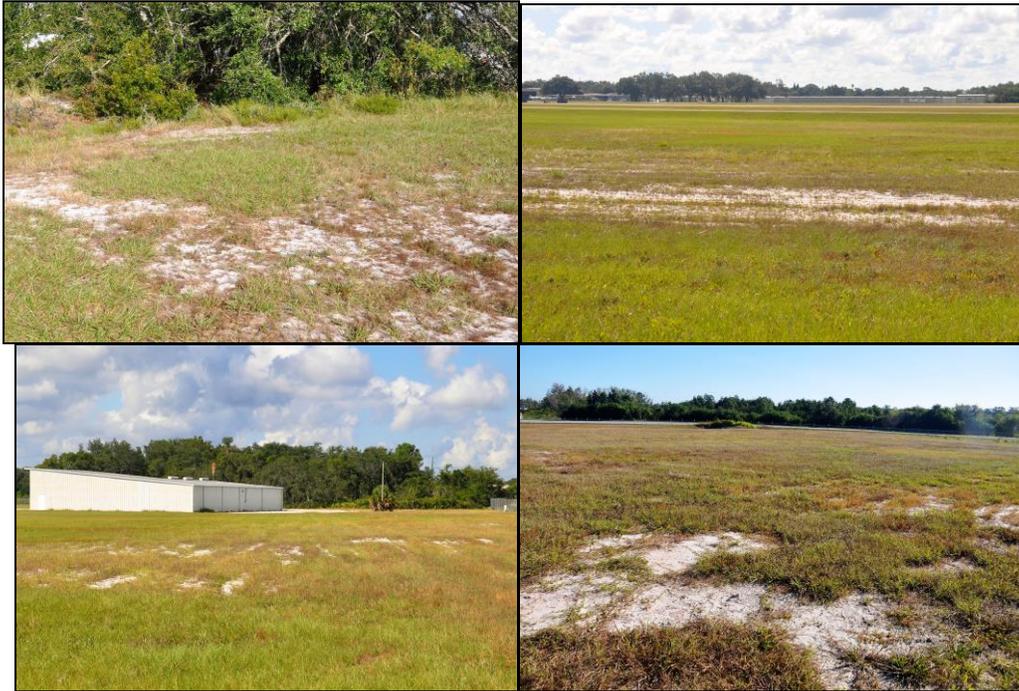
The AOA has two primary runways, Rwy. 5/23 and Rwy. 11/29, and main taxiways A, B, C, D, and F. Turf grasses comprised of primarily bahia grass (*Paspalum notatum*) within these areas appeared to be cut at a mowed height of less than 6-inches and approximately at a mower height of 4-5 inches. Although this turf height is lower than the FAA recommended turf maintenance range of between 6-12 inches, most of the turf did appear to be healthy and free from insect attracting flowering weeds in most areas. There were a few areas where the turf appeared to be cut too low resulting in scalping and opening these areas of barren sandy soils.

**TURF MOWING HEIGHTS TOO LOW IN SOME AREAS EXPOSING BARREN SANDS**

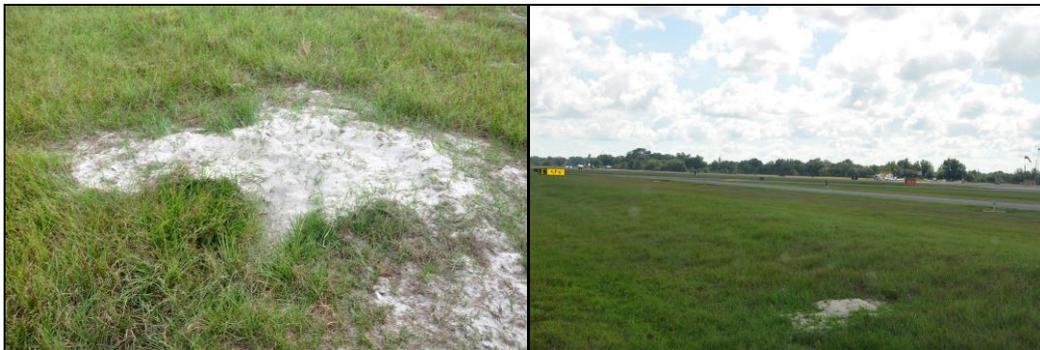
Open and barren sandy areas may attract various ground mobile wildlife that forage on bahia grasses and forage on other vegetation in the natural areas. Sandy barren areas attracts numerous Gopher Tortoises to areas within and close to active movement areas in the AOA. Gopher tortoise burrows may house several other wildlife species and attract meso-mammals that prey upon symbiotic wildlife that dwell in tortoise burrows.

**DOZENS OF GOPHER TORTOISE BURROWS SCATTERED WITHIN THE AOA**

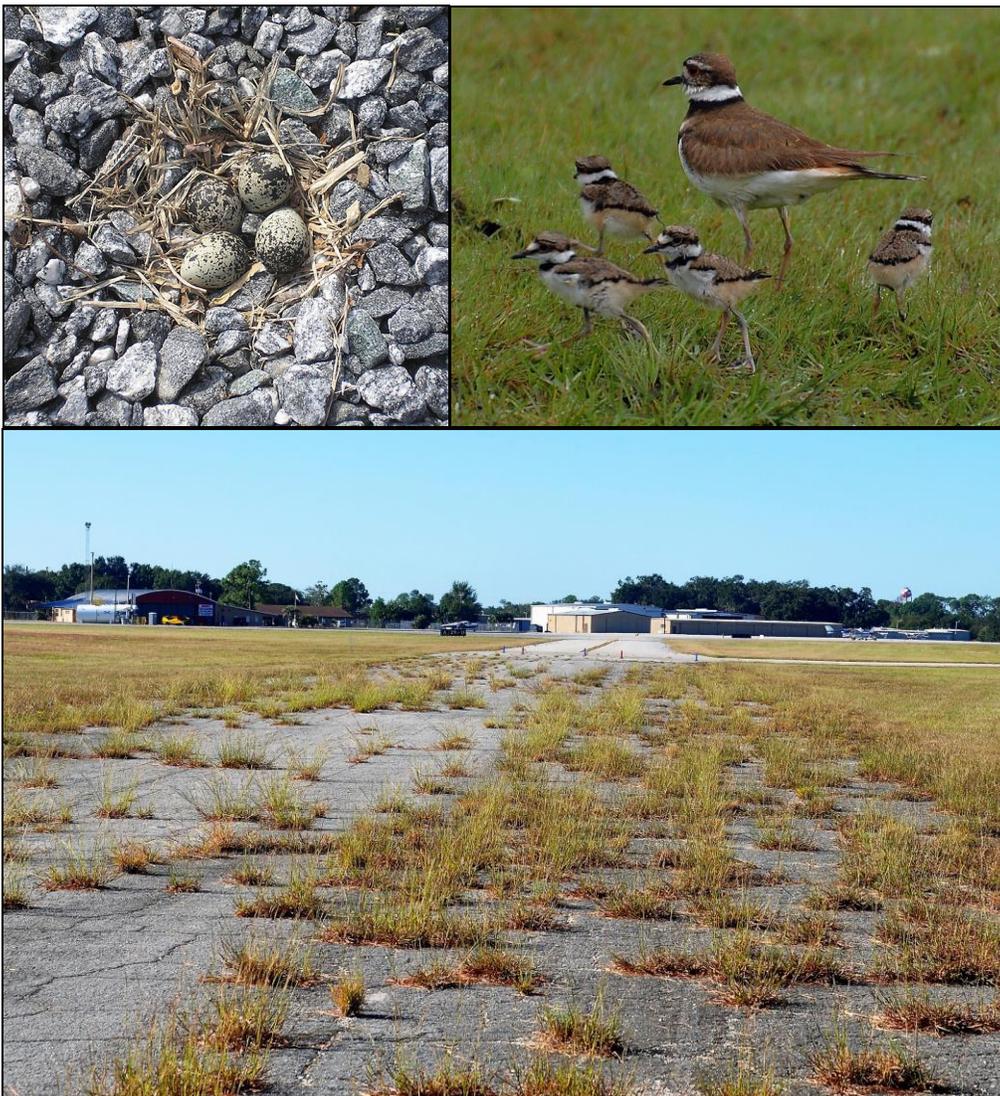
Weeds and relic grass emergence through former paved surfaces within the AOA can tend to create grit and gravel from the deteriorating pavement. These areas can attract small grass nesting birds collecting crop grit, as well as Killdeer (*Charadrius vociferous*) that frequent open ground with low vegetation (or no vegetation at all), including, driveways, parking lots, and gravel-covered roofs, and relic or cracked and fissured abandoned paved runways and taxiways at airports. This species is one of the shorebird species least water-dependent of all shorebirds, and is found at nearly all airports, particularly those in Florida. Nests are typically found in well-camouflaged gravel areas on old pavement.

**KILLDEER ATTRACTANT AREA WITHIN OLD PAVEMENT**

Preferred management practices to reduce this minor attraction would include a plan to remove the old pavement and stock-pile the milled asphalt for later use at the airport. Pavement that exhibits cracks and weed growth should be treated with herbicides to reduce weed growth and limit the attraction of wildlife foraging and grit collection.

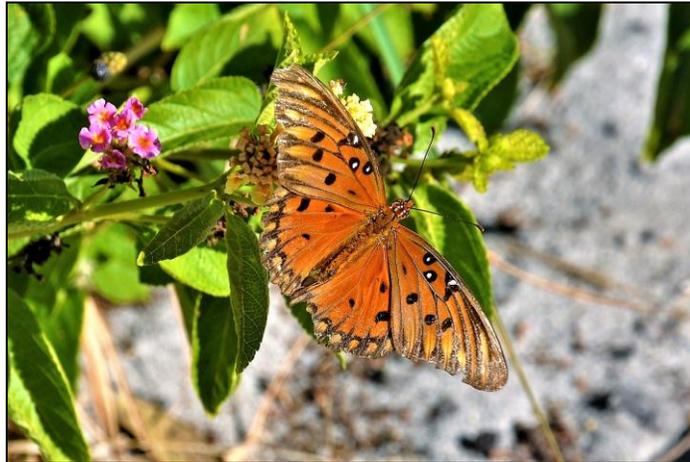
Flowering weeds including Lantana (*Lantana disambiguation*) were found primarily in the brushy areas adjacent to forested natural lands. Lantana and other noxious invasive vegetation species were found at various locations near the forested, uncleared areas around the airport.

**GULF FRITILLARY BUTTERFLY (*Agraulis vanilla*) ON LANTANA**

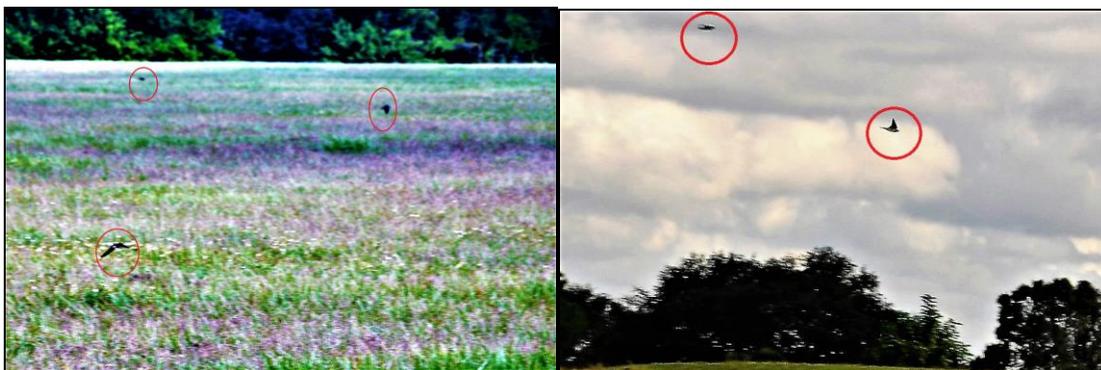
**ERRATIC SWALLOWS FLOCK FORAGE AIRBORNE INSECTS OVER FLOWERING WEEDS**

Tree swallows (*Tachycineta bicolor*) and Barn swallows (*Hirundo rustica*) regularly migrate through Florida. These aerial foragers feed in flight collecting a wide range of insects as they fly erratic sorties over open grassy fields.

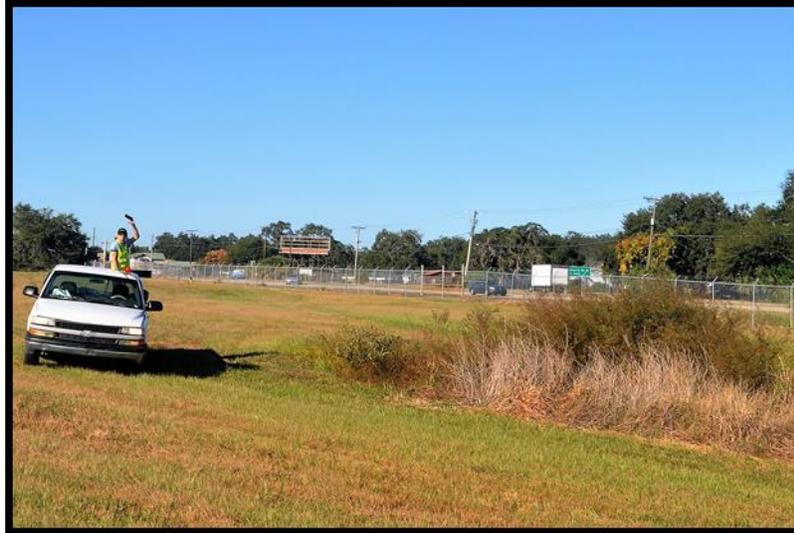
There were also some very small areas where it was clear that stormwater may collect and drain portions of the airport. These areas were extremely small in size and generally not considered a significant wildlife attract area, except that some wildlife may periodically hunt and forage in these areas when food or cover is limited. One such area was culverted and had high growth of weedy vegetation contained within it. This area was being sprayed with herbicides during the field inspection. Other areas also showed evidence of herbicide treatment performed by the crews from the City of Winter Haven.

**HERBICIDE TREATMENT ONGOING AT SMALL DITCH**

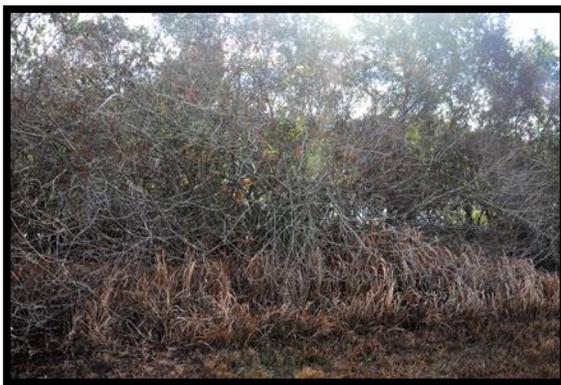
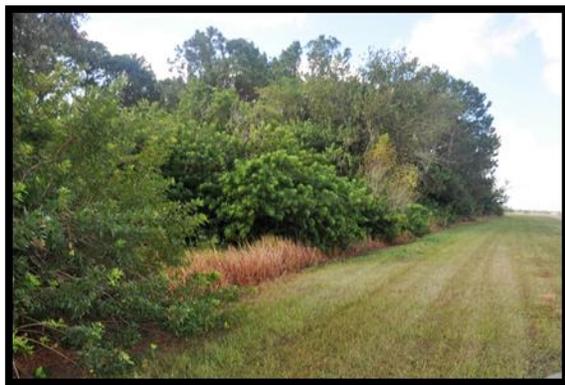
**HERBICIDE TREATMENTS OF NOXIOUS/INVASIVE VEGETATION**

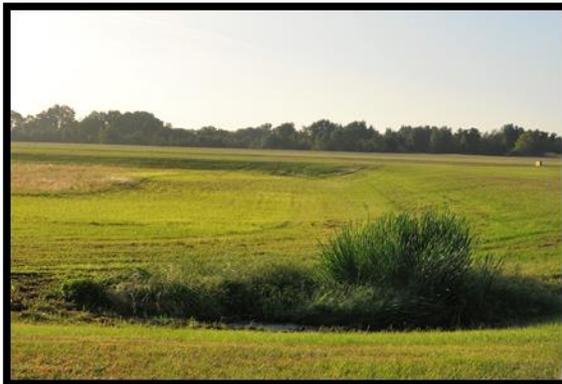
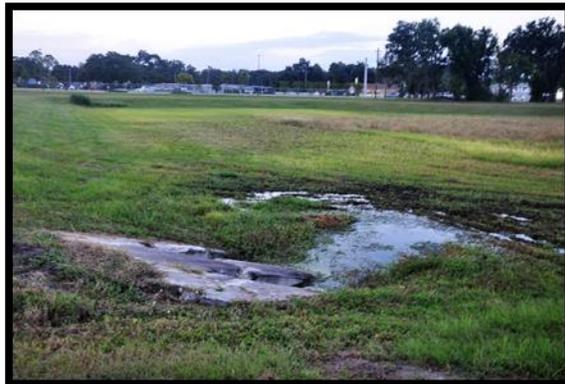
**WEEDY COVER VEGETATION & STANDING WATER REMAINS IN DRY DETENTION AREAS**

FAA recommends that standing stormwater should be drained and/or removed from areas within the AOA within 48-hours of a rainfall event. **AC 150/5200-33B Part 2-3 Water Management Facilities (a)** *On-airport storm water management facilities allow the quick removal of surface water, including discharges related to aircraft deicing, from impervious surfaces, such as pavement and terminal/hangar building roofs. Existing on-airport detention ponds collect storm water, protect water quality, and control runoff. Standing bodies of water that can attract hazardous wildlife. FAA requires immediate correction of any wildlife hazards arising from existing storm water facilities located on or near airports, using appropriate wildlife hazard mitigation techniques.*

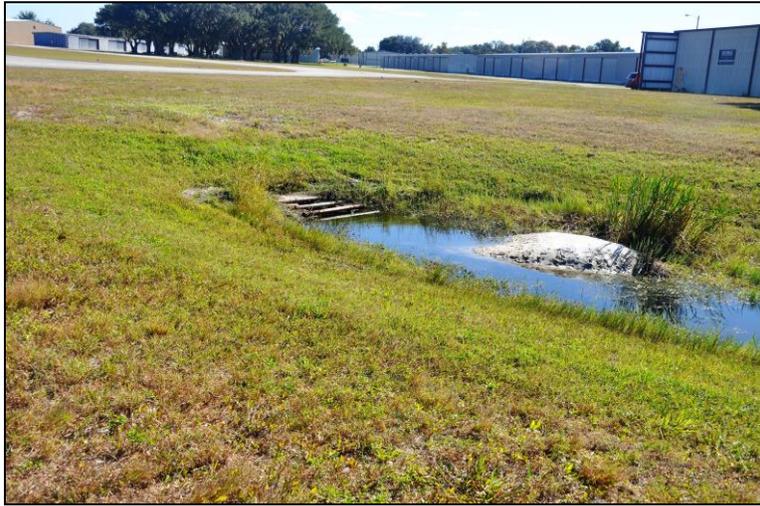
**INTERNAL GRATED CULVERT IN STORMWATER DITCH**

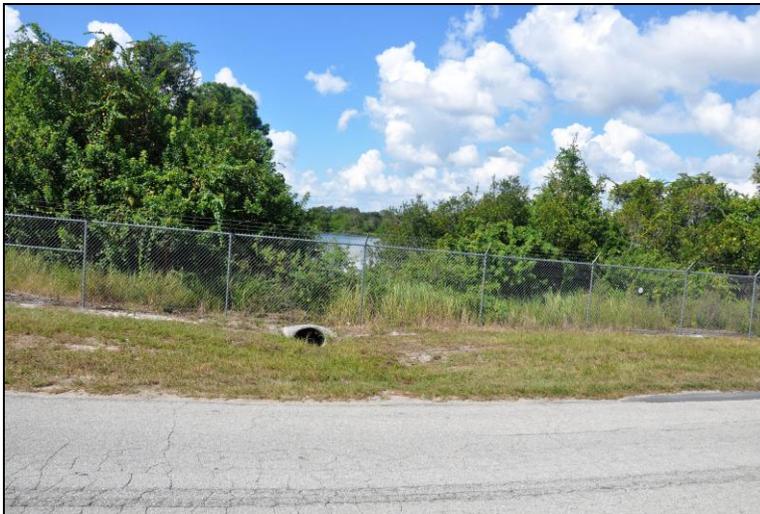
**DRAINAGE CULVERTS THAT EXTEND OUTSIDE THE AOA SHOULD BE GRATED**

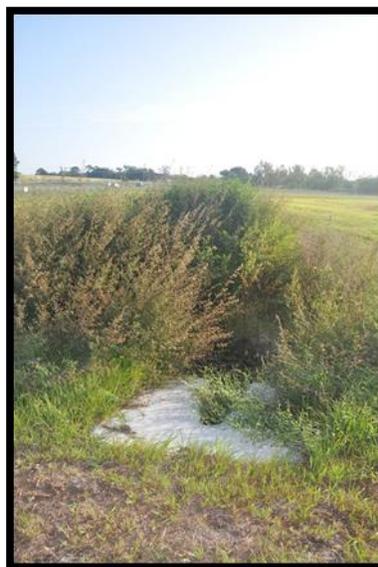
**CULVERTS SHOULD BE CLEANED FOR DRAINAGE FLOW**

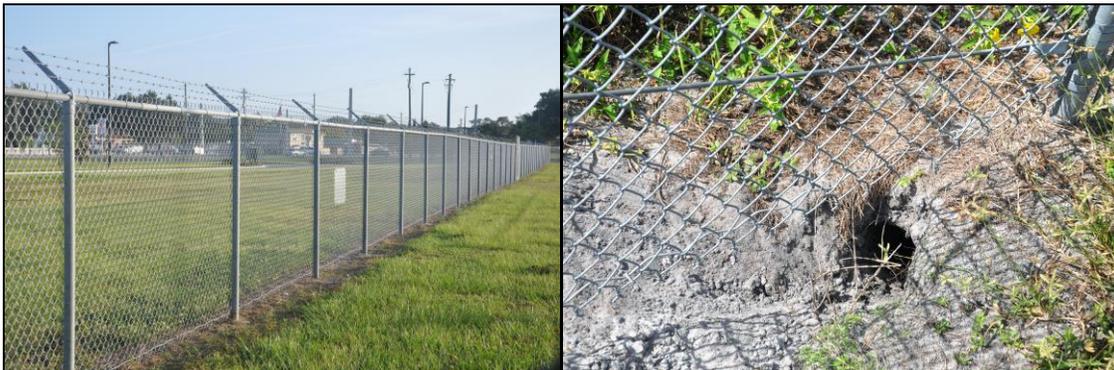
Several fence breaches were observed during the inspections. Many of these breaches can be repaired by fortifying the area with asphalt millings or fist-sized stones. Herbicide treatment was also recognized along many of the AOA fence bases. An 18-inch wide swath cleared along both sides the fence bases is beneficial in allowing for quick identification and repair of breaches dug from ground-mobile wildlife.

**CLEARED FENCE BASES ALLOWS FOR QUICK BREACH IDENTIFICATION AND REPAIR**

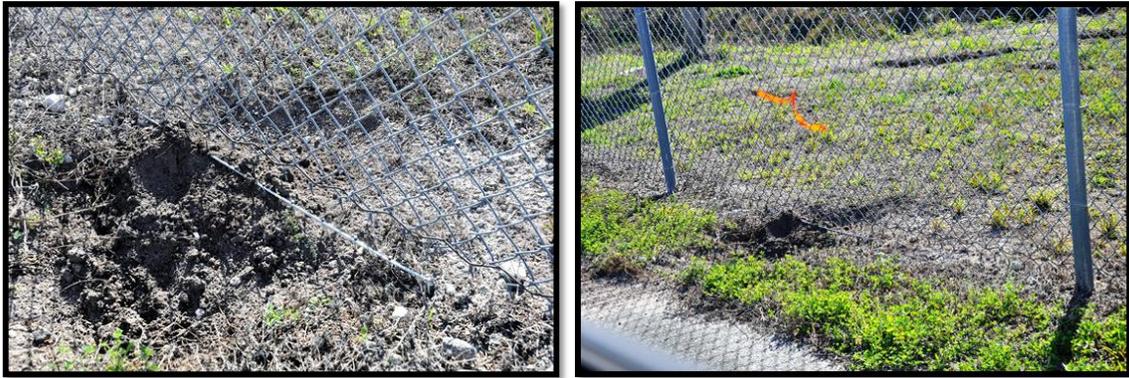
Dig Defence® products have recently been installed at several fence breaches around the AOA at other airports. These inexpensive products should help to reduce the numbers of wildlife incursions in the AOA.

**DIG DEFENCE® PRODUCTS ALONG AOA FENCE BASES**

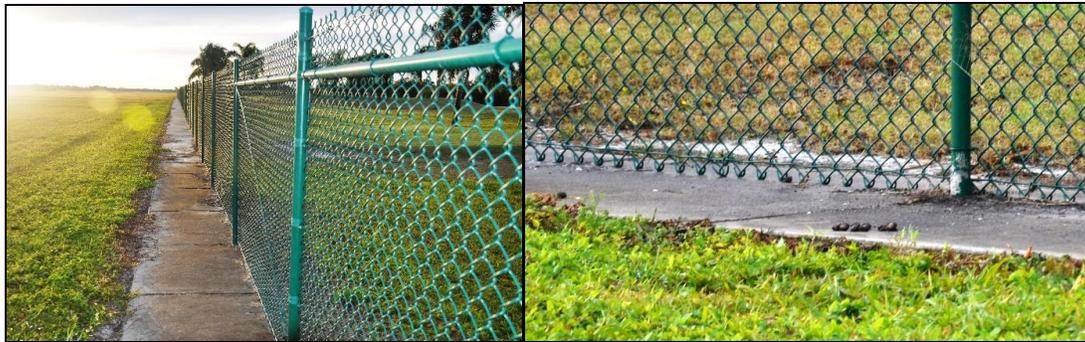
**CONCRETE MOW STRIPS ALONG AN AOA FENCE BASE**

Remediation to these trouble spots may include fortifying the fence base with either concrete mow strips approximately 18-to-20-inches wide, or installing the FAA recommended fence base with additional chain-link fabric to reduce wildlife intrusions.

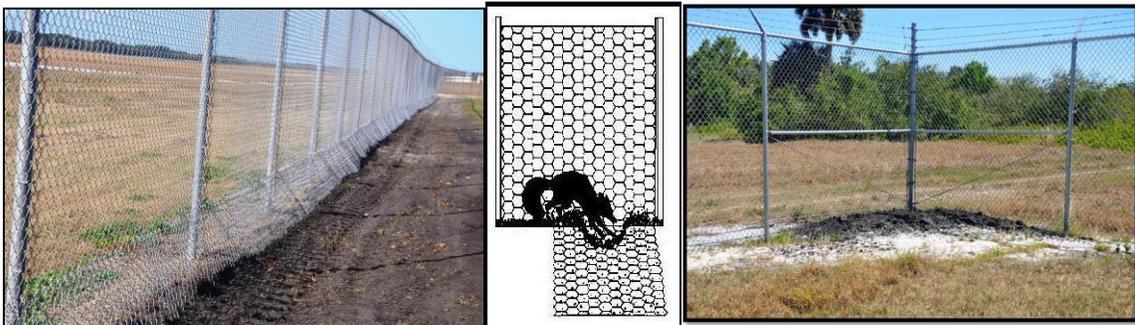
**OTHER AOA FENCE FORTIFICATION OPTIONS**

FAA recommended AOA fence base fabric installation and ample fortifications with asphalt millings along former breaches, and particularly at AOA fence corners can help to reduce fence base breaching.

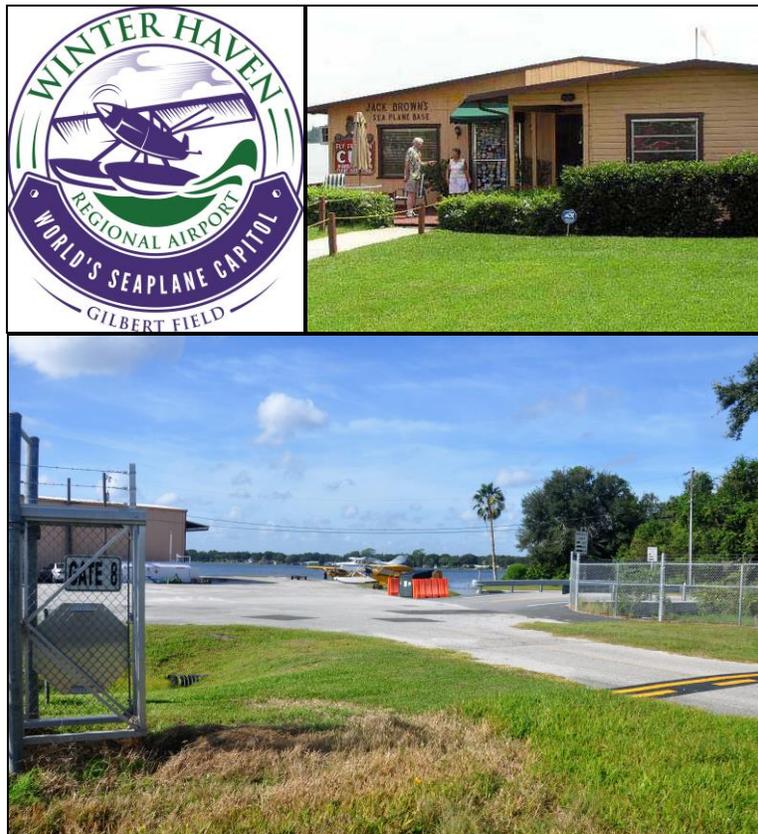
Gate 8 at the access to Brown's Seaplane Base was found open during each of the site visits. Gates that remain routinely open can allow various wildlife free passage onto the active movement areas of the airport.

**BROWN'S SEAPLANE BASE AT WEST SIDE AOA**

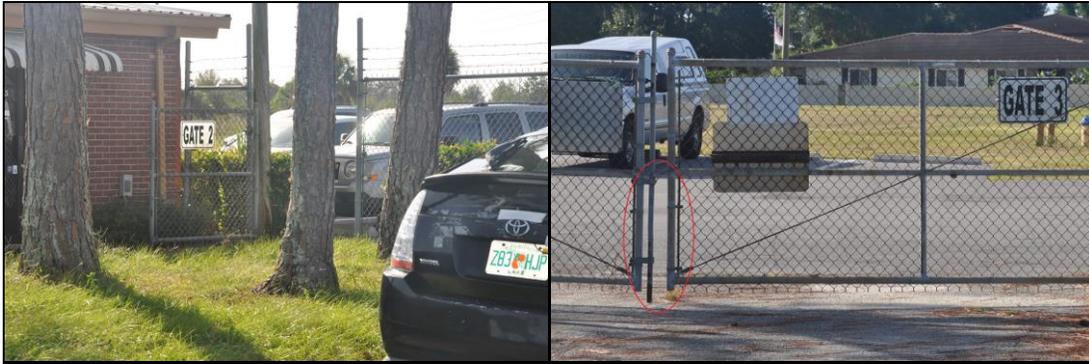
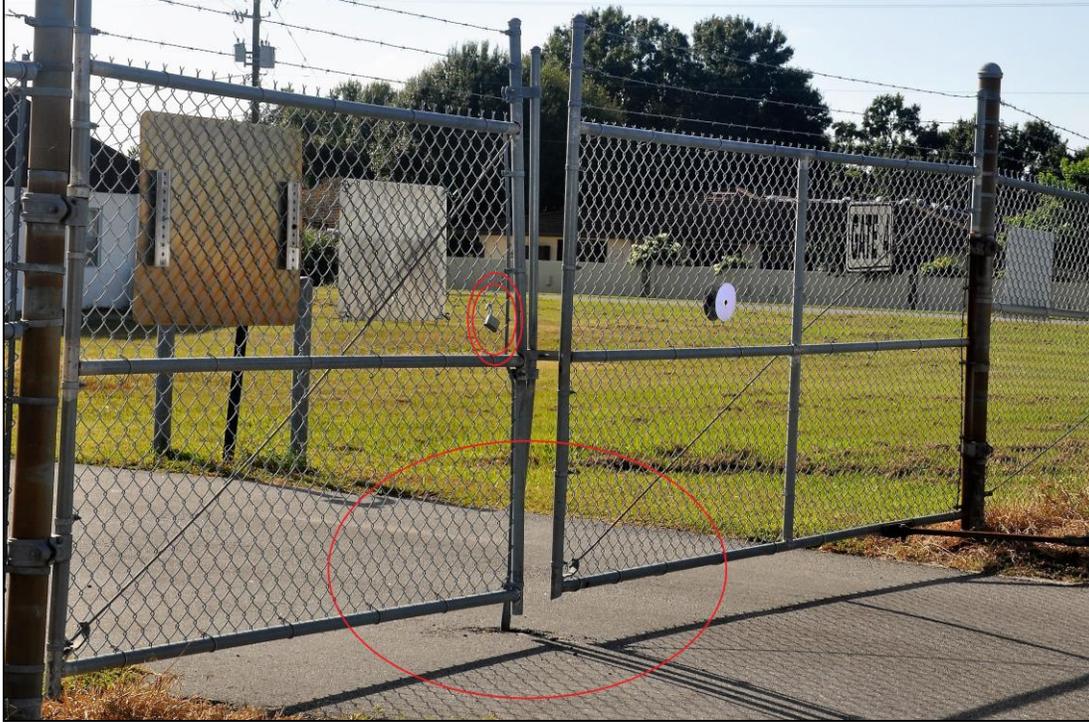
**GATES 2, 3, AND 4 RESPECTIVELY NEED ATTENTION**

Exclusion gate modifications should also be installed at Gates 2, 3, 4, 5, 6, 6A, 7, 8, 9, 14, 16, and 17, as well as any other gates around the AOA where base horizontal or vertical gaps greater than 4-inches are obvious. Most of the gate modifications can easily be rectified by simply re-adjusting the gate hinges and openings with either additional hardware or installing speed bumps either beneath the gate or on one side or the other to reduce the horizontal gaps to 4-inches or less. With human access gates, tenants should be instructed to properly close gates following ingress or egress. Ground mobile wildlife are generally cunning and capable of moving rapidly through open gates.

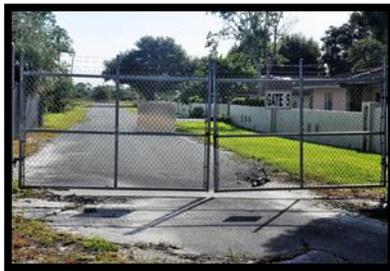
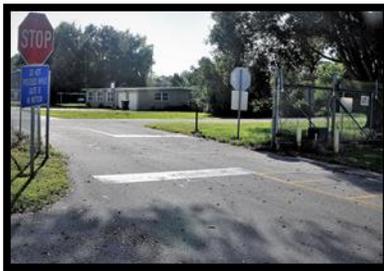
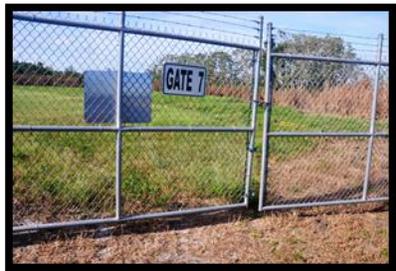
**GATES 5, 6, AND 7 RESPECTIVELY NEED ATTENTION**

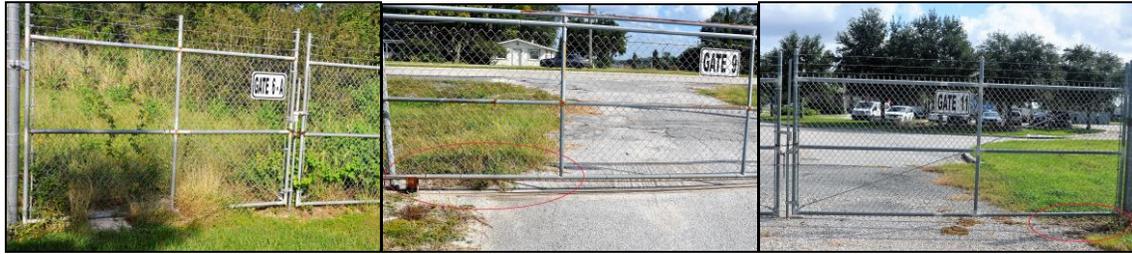
**GATES 6-A, 9, AND 11 RESPECTIVELY NEED ATTENTION**

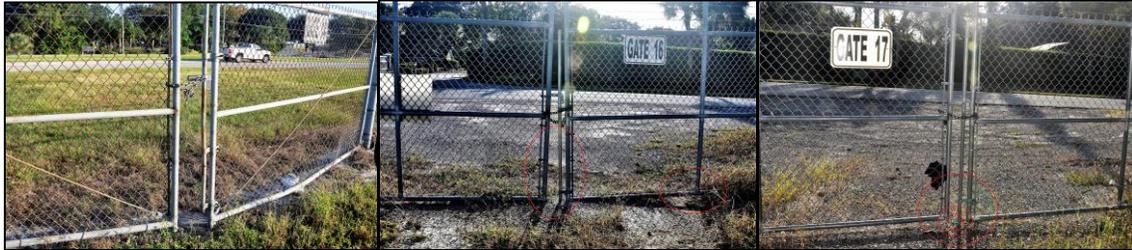
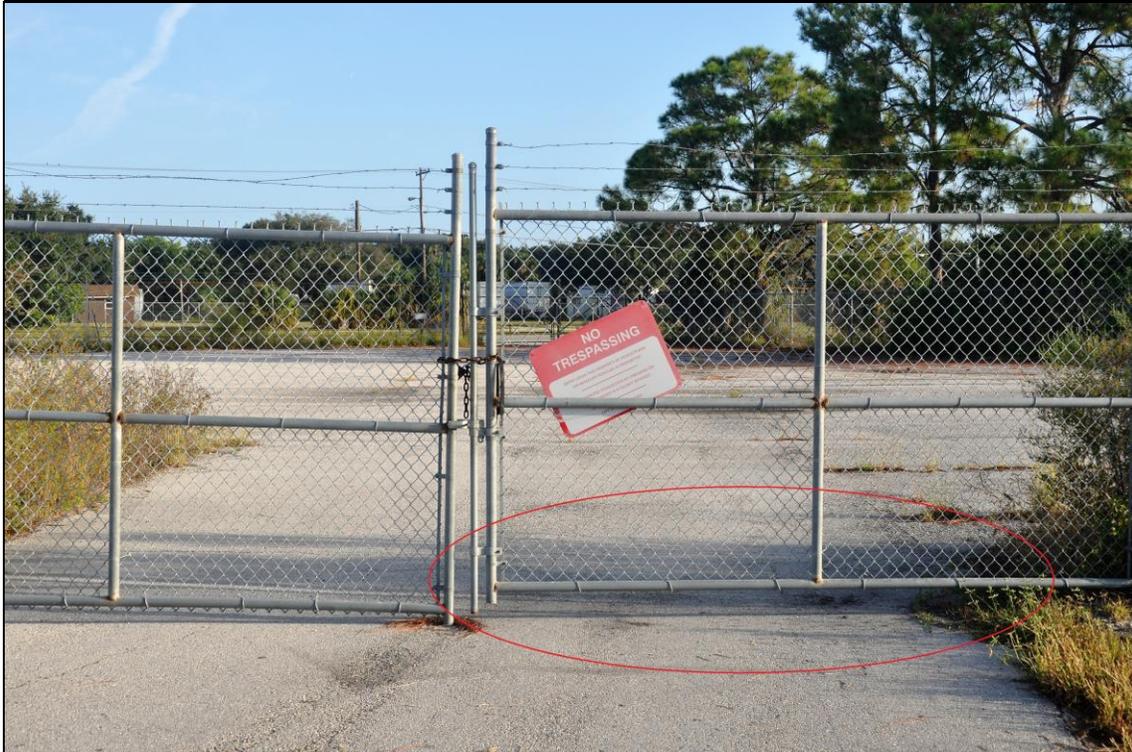
**GATES 14,16, AND 17 RESPECTIVELY NEED ATTENTION**

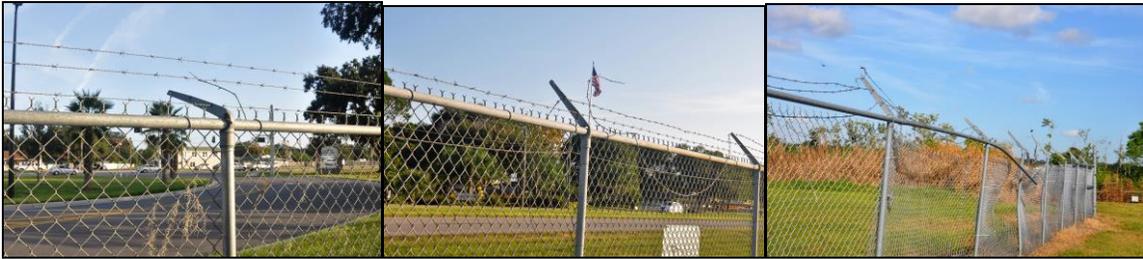
Three-strand barbed-wire outriggers are installed around AOA fences to keep climbing wildlife from entering the airport. There are a few spots where the outriggers have been damaged and the barbed-wire is missing and these areas should also be repaired or replaced.

**OUTRIGGER AND BARBED-WIRE REPAIRS NEEDED ALONG AOA FENCES**

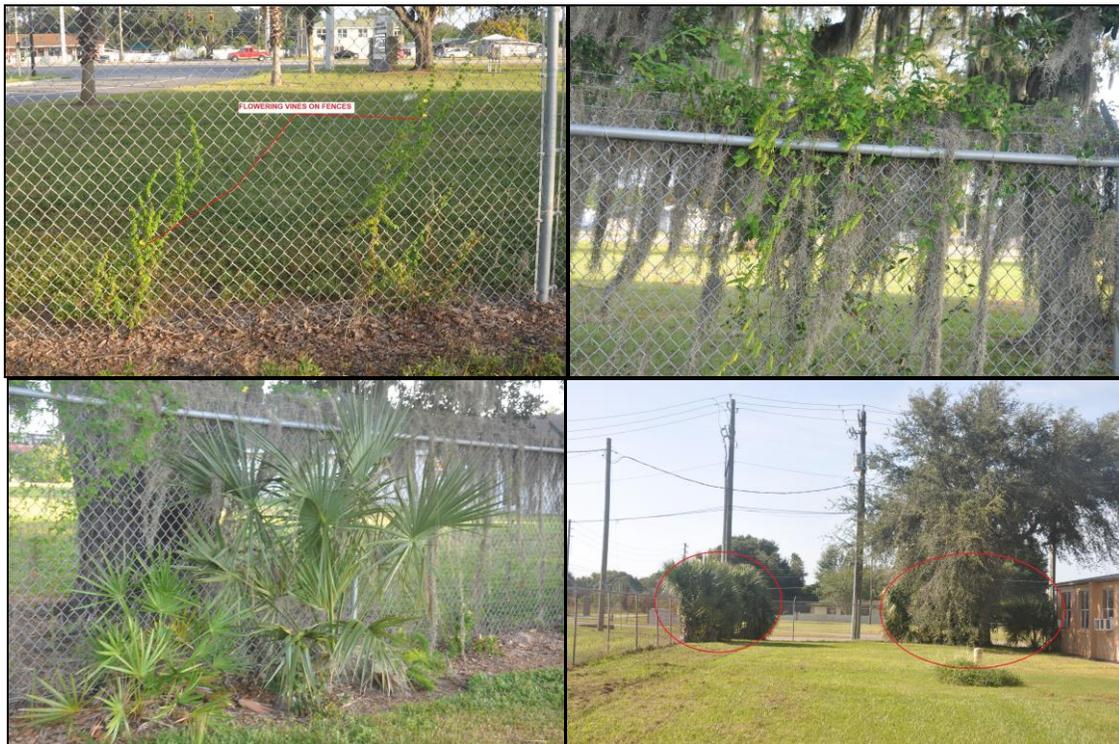
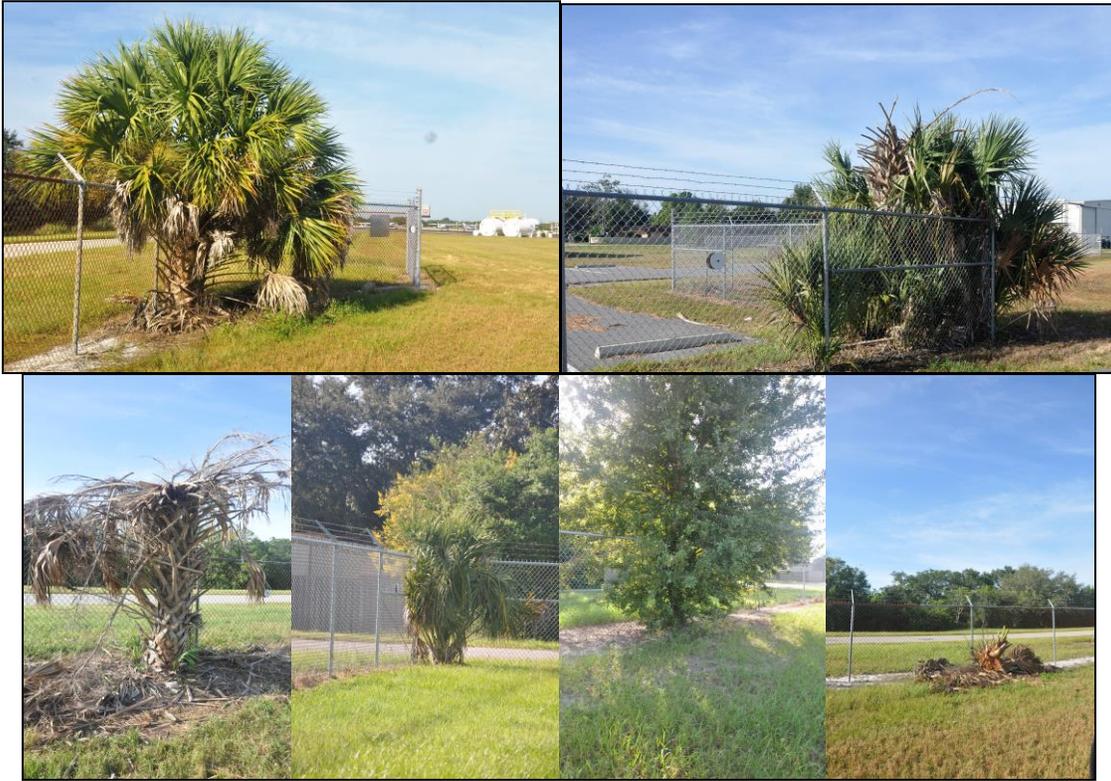
AOA fence maintenance is critical to reducing hazardous wildlife attractants at airports. Fences that are being compromised with vines, weeds, shrubs, palm, and trees should be cleared.

**VEGETATION COMPROMISING AOA FENCES SHOULD BE REMOVED**

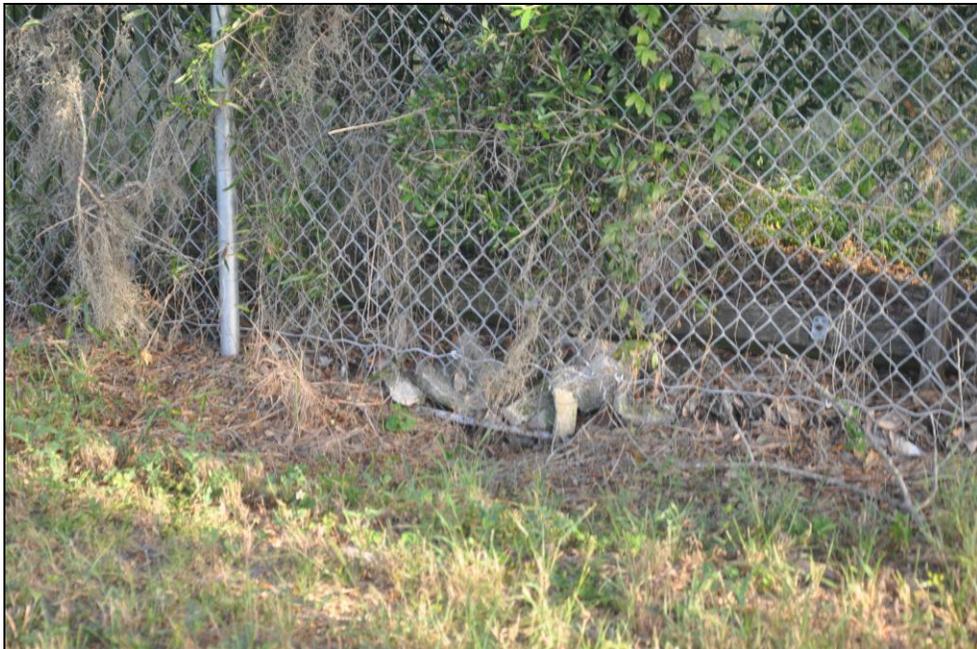
**BREACH FILLED BENEATH THE AOA FENCE**

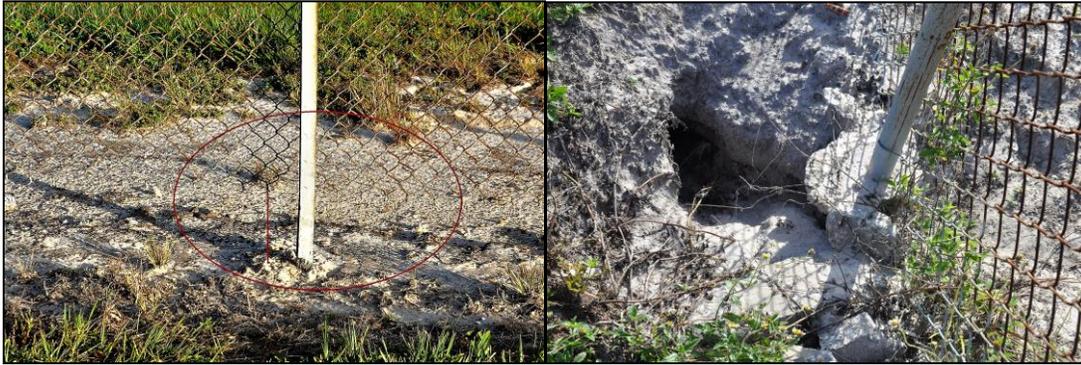
Ground surface fence bases should be maintained to prevent wildlife from entering the AOA. Some of the fence bases exceed the minimum 4-inches gaps heights. This may have been caused by maintenance equipment that accidentally hit the fence, or other factors such as soil subsidence and erosion around fence posts. In any event, these flaws in exclusion fencing should be repaired and/or replaced.

**SOIL SUBSIDENCE AND EROSION BURROW AT FENCE POSTS REQUIRES REPAIR**

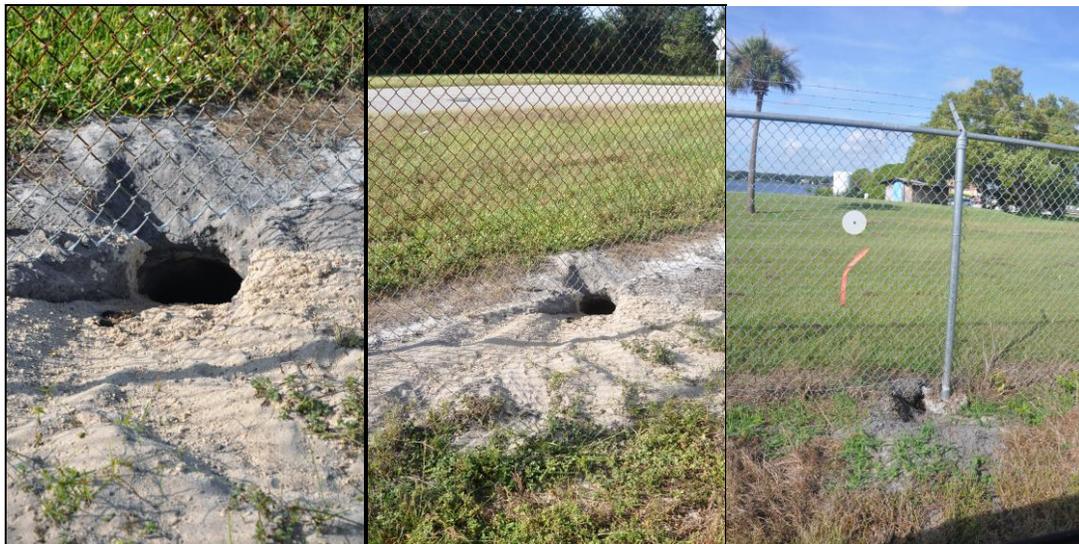
**AOA FENCE WILDLIFE BREACH AREAS NEEDING RECTIFICATION**

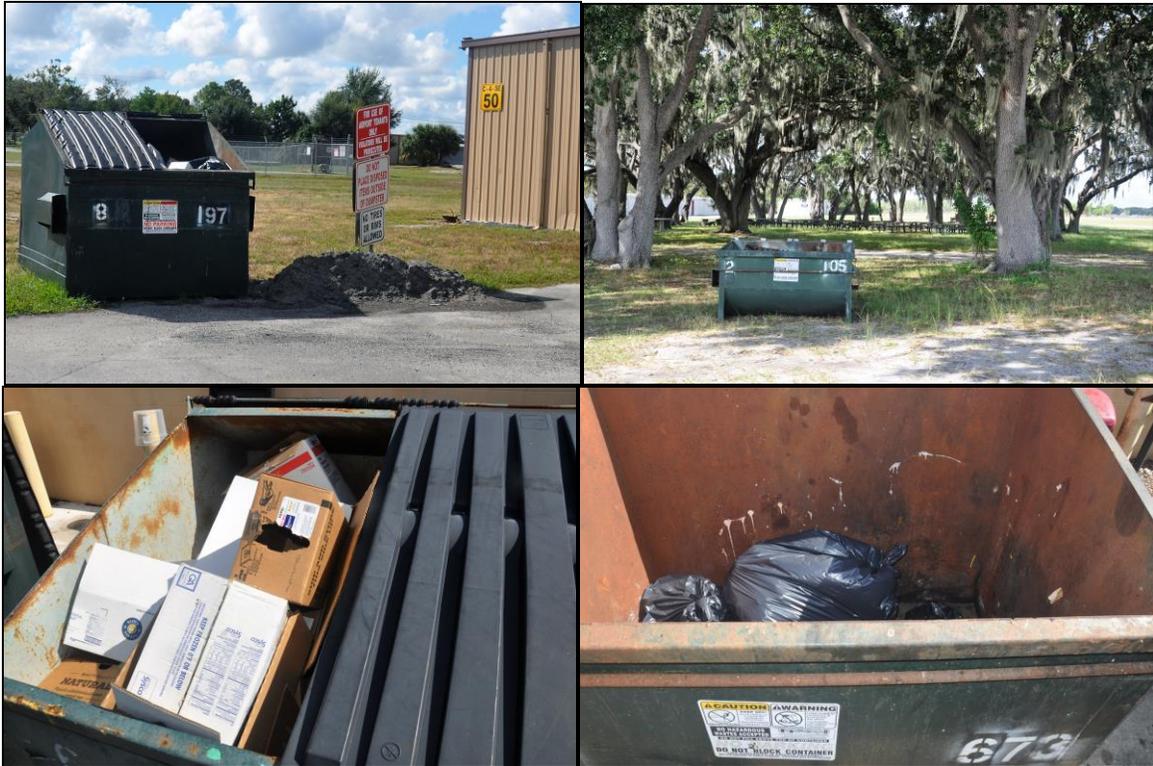
#### DUMPSTER MAINTENANCE

Other physical attractants that are sometime overlooked at airports is trash containment, i.e. dumpster management. American crows, vultures, and a wide range of ground mobile wildlife will congregate and forage on garbage and food items discarded in dumpsters. Dumpsters that are associated with air terminal café and restaurants, are of a particular concern as food wastes are frequently discarded in the dumpsters just outside the AOA, and in some cases inside the AOA near hangers and tenant facilities. A No-Feeding policy should be employed at all airports and tenants should be reminded to keep dumpster lids closed at all times. It may be the responsibility of some tenants or airport staff to check the dumpsters after the waste collection companies go through the properties to ensure that the lids are closed. Several dumpsters were found open during each of the field inspection periods.

FAA Order NG 1050.3G, Part 6 (f) issued 12/1/2013 specifies: *All dumpsters and refuse containers outdoors or exposed to stormwater shall be covered at all time and shall not spill, dump, or otherwise leak or discharge liquids, semi-liquids or solids from the containers.*

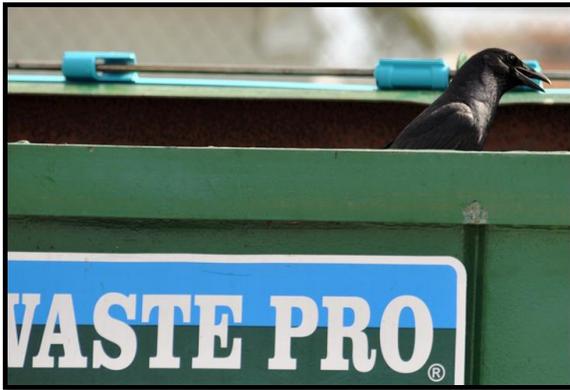
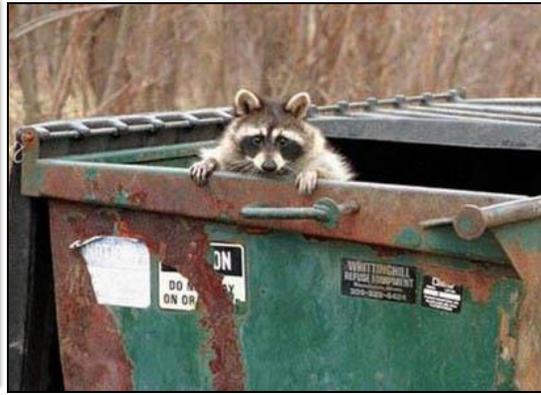
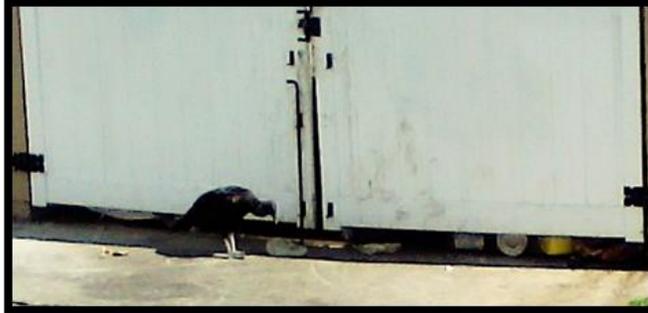
#### **WILDLIFE FORAGING AT OPEN DUMPSTERS AT OTHER AIRPORTS**

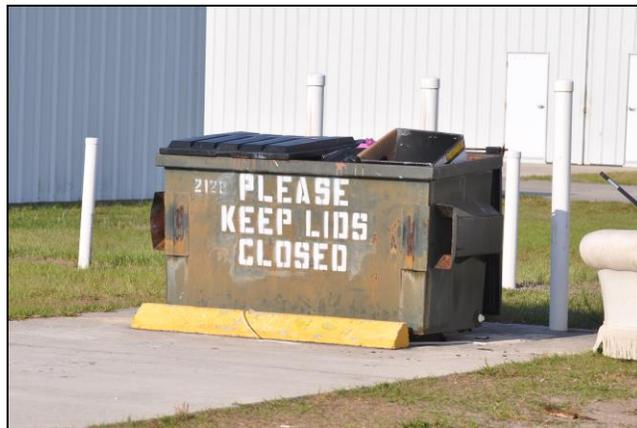
#### **BOLD DUMPSTER MARKING MAY HELP AS A REMINDER**

Unfortunately, most of the waste collection haulers will not pay special attention to make sure the lids are properly closed after they empty the containers. This usually requires either the tenants or the airport staff to check each container to ensure closure following hauler pick-up. It is nevertheless important to try to rectify and reduce possible wildlife usage on airport property.

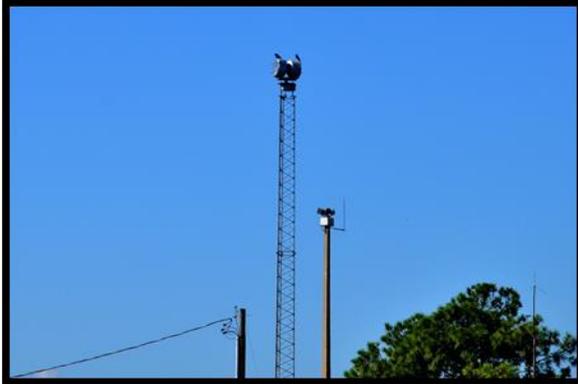
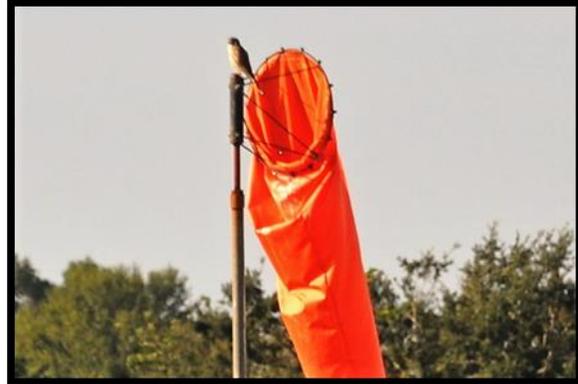
**TWO CROWS PERCH ON BEACON - ONE KESTREL PERCHED ON DAMAGED WINDSOCK**

New plastic anti-perching strips are now available on the market. Using these products should help to reduce wildlife perching, and reduce guano build-up and possible corrosion of electrical devices while reducing maintenance costs.

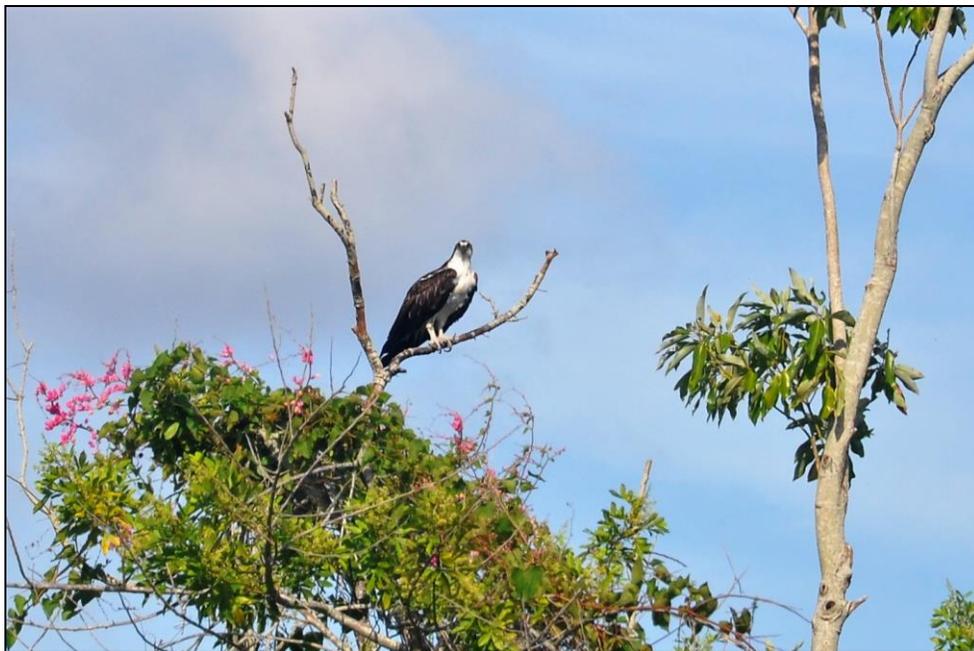
**OSPREY PERCHED ON SNAG ALONG WEST SIDE OF AOA**

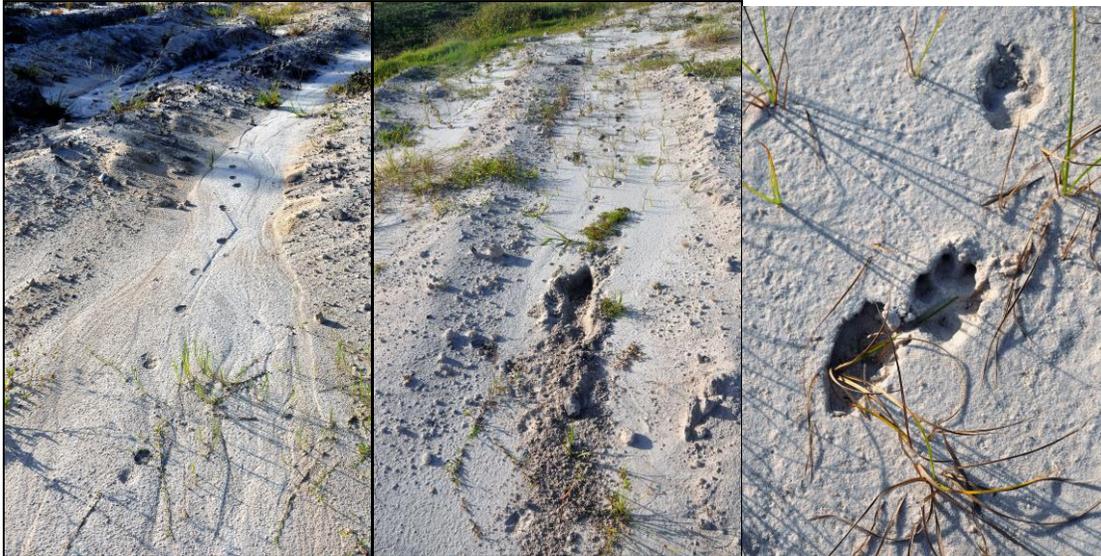
Wildlife hazing and harassment was not apparent during any of the inspection visits. No evidence of White-tailed deer was obvious anywhere on the airport. Coyote tracks were found along the east side of the AOA. The FAA National Wildlife Strike Database reports 31 coyote strikes on Florida airports from 1995 through February 13, 2018. At least 3 strikes were reported as either Minor damage (M) or Minor damage uncertain (M?). Of those reported, 9 of the strikes occurred at Tampa International Airport (TPA) and 5 of the strikes occurred at Orlando International Airport (MCO). Together these coyote strikes were also associated with larger central Florida airports and accounted for roughly 45% of the total reported.

**FRESH ADULT AND SUB-ADULT COYOTE TRACKS ON SAND MOUND AT EAST AOA**
