**WINTER HAVEN'S GILBERT AIRPORT (KGIF)  
WILDLIFE HAZARD SITE VISIT  
WINTER HAVEN, POLK COUNTY, FLORIDA**

**NOVEMBER 6, 2018**

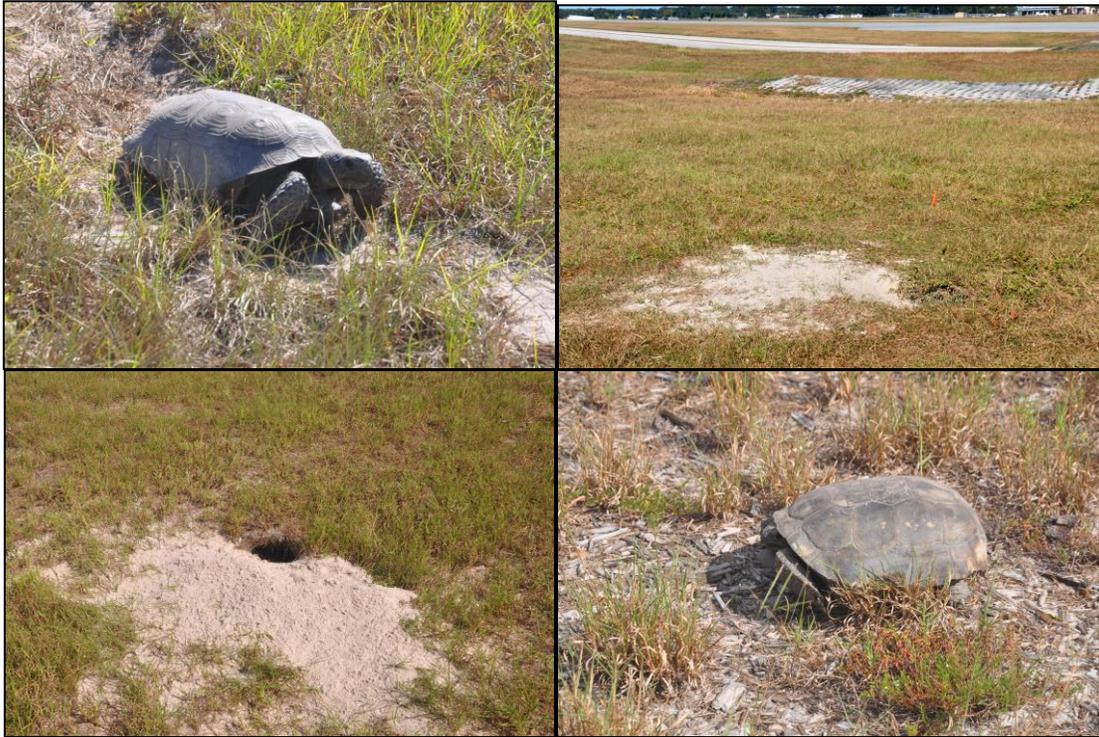
Dozens of Gopher Tortoise burrows were flagged and photographed at nearly all areas within the AOA. Although 25 burrows were counted and flagged during the first field inspection, many additional burrows were found during the second and third field visits. Most of the burrows appeared to be active as evidenced with fresh slide markings and scat in the vicinity of the borrow openings. Tortoise incursions are generally not a serious threat to aircraft safety, but when an aircraft veers off a runway or taxiway, and the landing gear hits one of the large burrows, damage to the landing gear may occur, resulting in an expense to the aircraft owners. Several burrows were observed that were clearly in the Runway Safety Area (RSA).

Gopher tortoises are listed as a threatened species in Florida, and mitigation efforts (i.e., tortoise removal or relocation and burrow eliminations) are heavily regulated, expensive, and time-consuming. However, gopher tortoises burrowing in such close proximity to runways are a safety hazard to aircraft that may leave the runway pavement surface.

**NUMEROUS GOPHER TORTOISE BURROWS AT SEVERAL LOCATIONS IN THE AOA**

Artificial turf that meets the specifications in FAA Advisory Circular 150/5370-15B has been identified as a material that can be used to cover large portions of airport property with multiple benefits, such as providing consistent ground cover, as well as reducing maintenance costs and attractive vegetative food sources for hazardous wildlife species. It was determined that research was necessary to assess artificial turf as a potential solution for mitigating the burrowing behavior of gopher tortoises on the airport property.

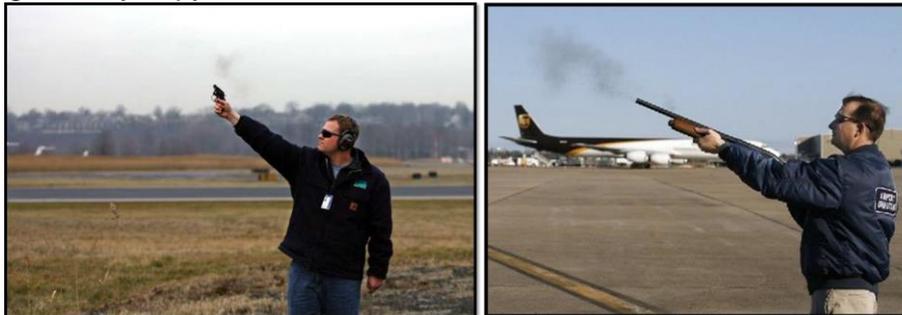
Pyrotechnics are generally preferred for avian wildlife that are foraging or hovering over an airport. A large variety of pyrotechnics are available from various vendors.

**A SEVEN SHOT PYROTECHNIC LAUNCHER AND SHELLCRACKER SHOTGUN**

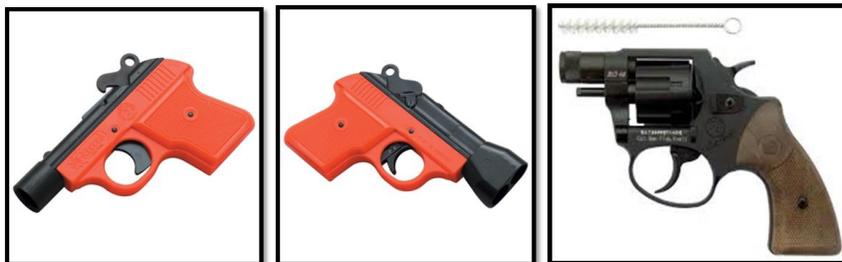
**SINGLE SHOT, DOUBLE SHOT, AND SEVEN SHOT PYRO LAUNCHERS**

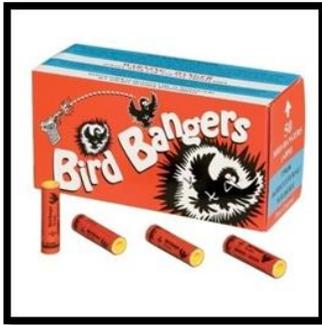
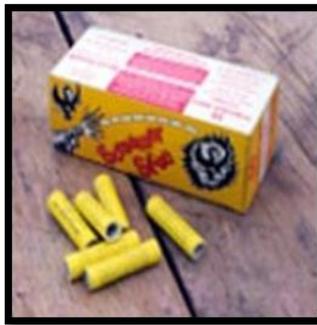
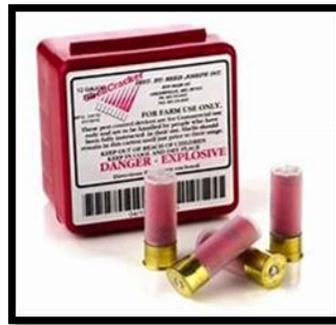
### **BIRD BANGERS, SCREAMER SIRENS, AND SHELLCRACKERS**

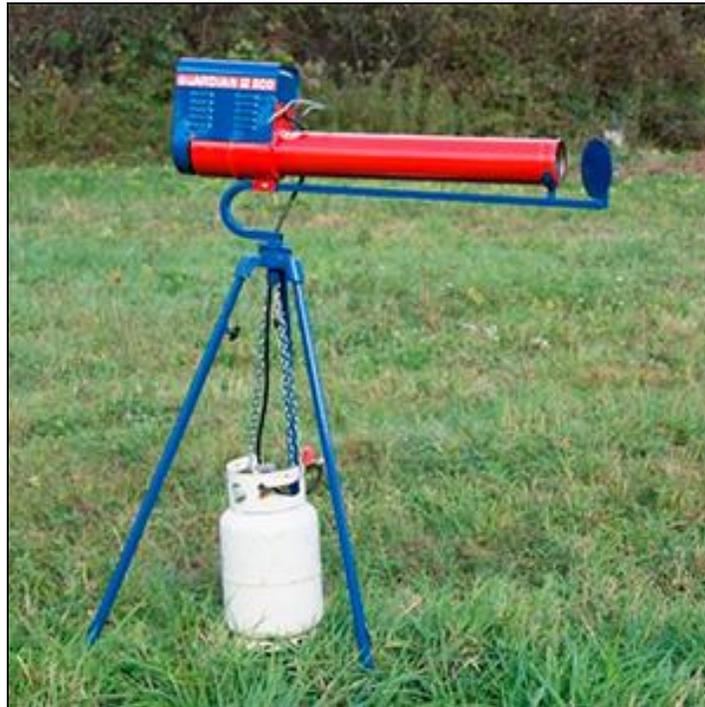
Economical gas scare cannons are the perfect solution to keep pest birds and wildlife away from airports. The cannons can cover up to 7-10 acres, based on the layout and topography of the land.

### **PROPANE SCARE AWAY CANNON**

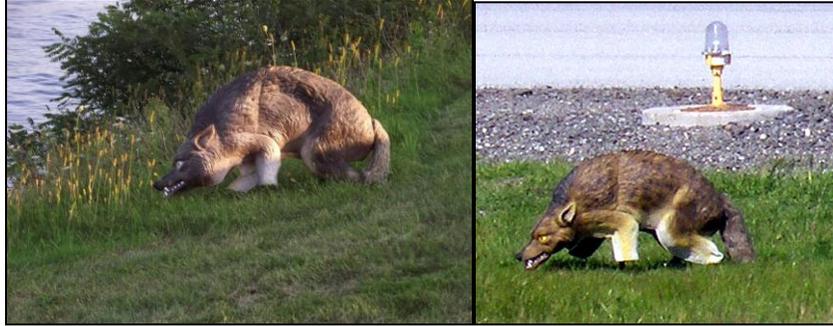
**COYOTE EFFIGY AS HAZING/HARASSMENT TECHNIQUE**

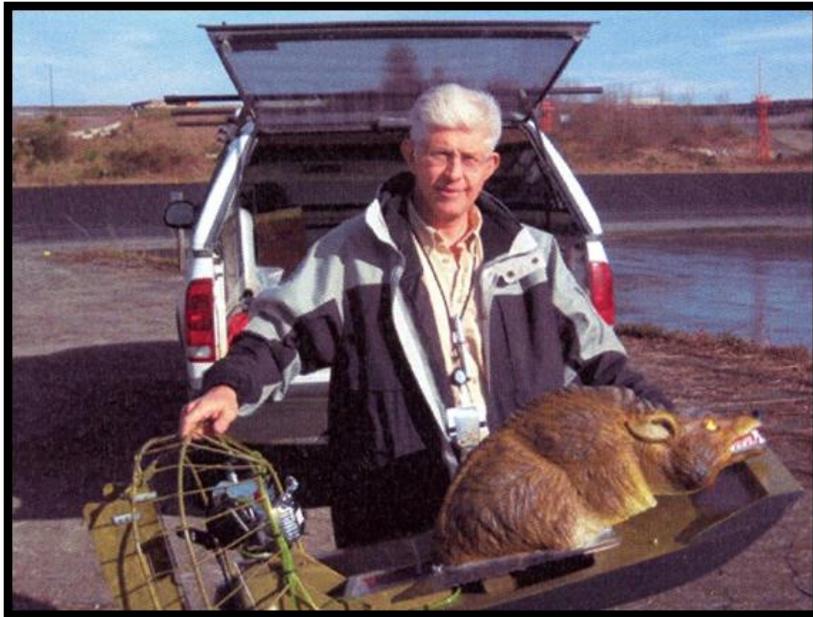
**PLASTIC COYOTE DECOYS**

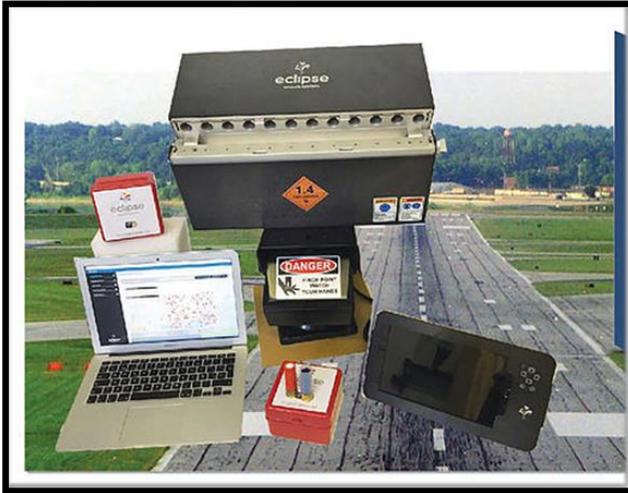
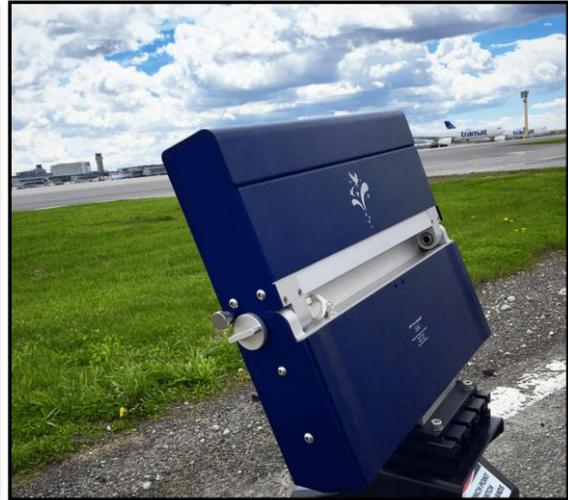
The remote-control pyrotechnics launcher from Eclipse allows for multiple pyrotechnics rounds to be fired remotely from a pivoting and tilting firing array.

### **ECLIPSE PYROTECHNICS SYSTEM AND REMOTE 12-GAUGE SHELL LAUNCHER**

EWC Pyro System is a Military Grade Heavy Duty 12-Gauge Pyrotechnics System wireless activated exclusive designed for bird control, with two maximum goals. Enhance the safety of the users, and to increase the effectiveness of the pyrotechnics. Four diverse types of shellcracker/12-gauge hazing/harassment rounds area available.

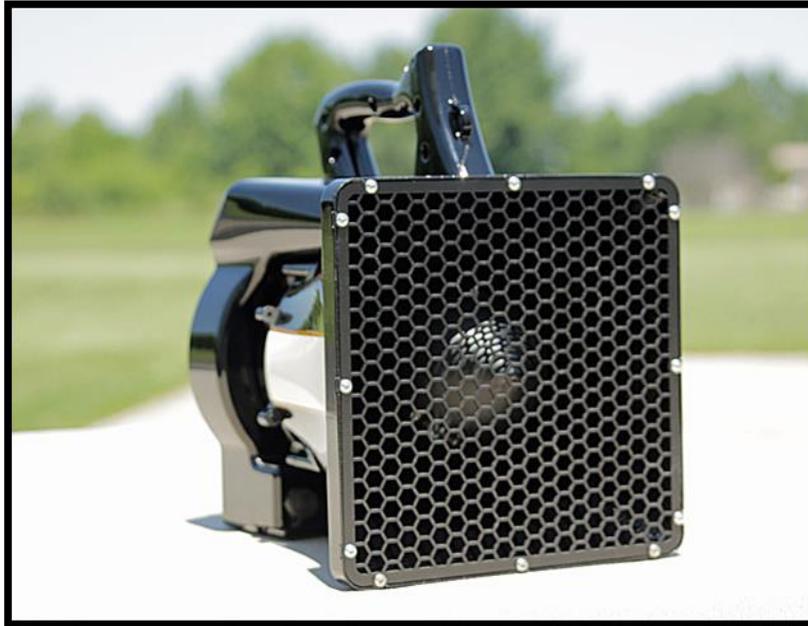
**HYPERSPIKE HS-10**

The Hyperspike HS-10 Portable Acoustic Device combines a variety of high intensity sounds with an output of 144 dB for a communication range of up to 750+ meters. This device can be used to haze wildlife at higher distances than most pyrotechnics will reach and when combined with other hazing techniques, can be very effective in managing wildlife problems around airports.
